# **Hay Point Coal Terminal**

## **Marine macrophyte assessment for potential mooring sites – October 2020**

**Report No. 21/03**

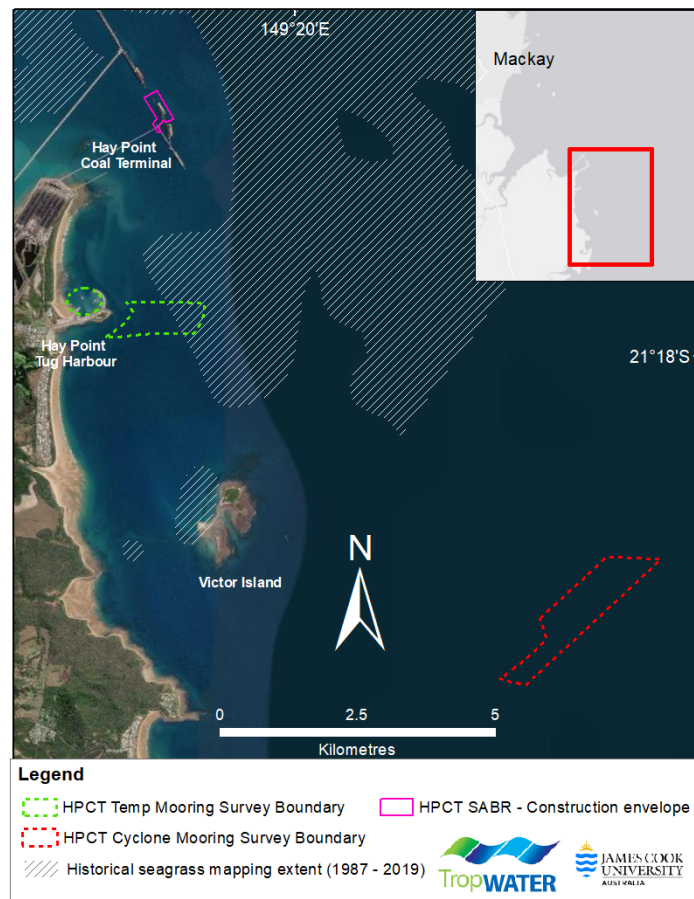
**Figure 1.** Marine macrophyte survey area showing survey boundaries for proposed temporary mooring and cyclone mooring locations and seagrass distributions from historical mapping from the JCU/NQBP long term seagrass monitoring program.

Hay Point Coal Terminal (HPCT) is assessing proposals for works to install temporary moorings both inside the Half Tide Tug Harbour (HTTH) and in an area directly to the east of the tug harbour for vessel usage during the construction phase of their Shiploader and Berth Replacement (SABR) Project (Figure 1). Additionally, HPCT has also proposed to use an area for cyclone moorings approximately 5-10 km off the coast to the south east of Victor Island that has commonly been used for this purpose in the past (Figure 1).

As part of an information gathering process relevant to both Commonwealth and State (Queensland) approval requirements, Advisian, the lead environmental consultant for the project commissioned the Seagrass Ecology Group at the Centre for Tropical Water and Aquatic Ecosystem Research (TropWATER), James Cook University to conduct marine macrophyte surveys within the area of works for potential moorings. Specifically, TropWATER examined the extent of marine plants (seagrass and macro-algae) growing within the proposed temporary mooring and cyclone mooring boundaries (Figure 1).

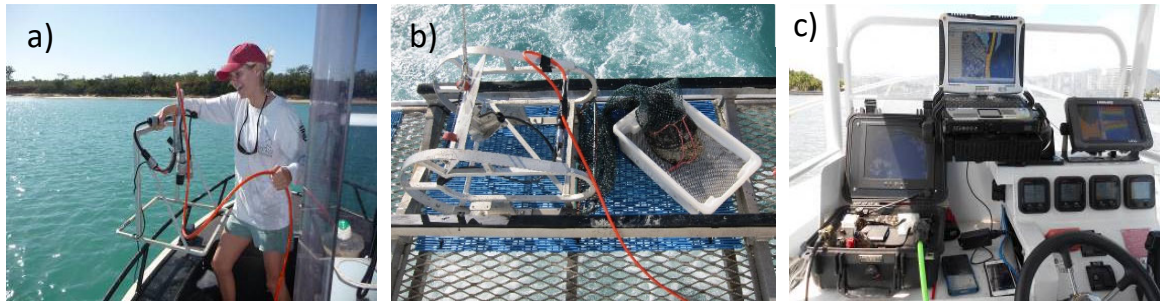
**Figure 2.** Monitoring set ups for marine macrophyte habitat assessments using live digital cameras (a & b) and on-vessel assessment, spatial referencing and recording of images (c).

1. Shallower inshore habitat (1-12 m deep) for the proposed temporary moorings were monitored from a small vessel using a digital camera mounted on a drop frame that provided a live feed to a monitor on the surface. The transmitted image incorporated a 0.25m<sup>2</sup> view of a quadrat on the seafloor from which a researcher could estimate habitat cover, biomass and species or functional groups present (Figure 2a & c). At each site key seagrass, macro-algae and sediment information from three random placements of the quadrat were collected.

2. Deeper offshore habitat (11-14 m deep) including the cyclone mooring area were monitored from a large research vessel using a towed digital camera system mounted on a sled that incorporates a net 600 mm wide and 250 mm deep with a net of 10 mm-mesh (Figure 2b). At each survey site, seagrass and macro-algae will be sampled along a 100 m transect at drift speed and assessed at 10 random video grabs from the digital videotape. Footage was observed on a TV monitor on board the vessel and also recorded. Marine plant samples captured in the net were used to confirm benthic algal and seagrass taxa or functional groups observed on the monitor. Transect footage was used to determine seagrass meadow and macro-algae habitat characteristics including seagrass meadow area, species composition, above-ground biomass, percent algal cover, depth below mean sea level (MSL), sediment type and time and position (Global Positioning System) fixes. (Figure 2c).

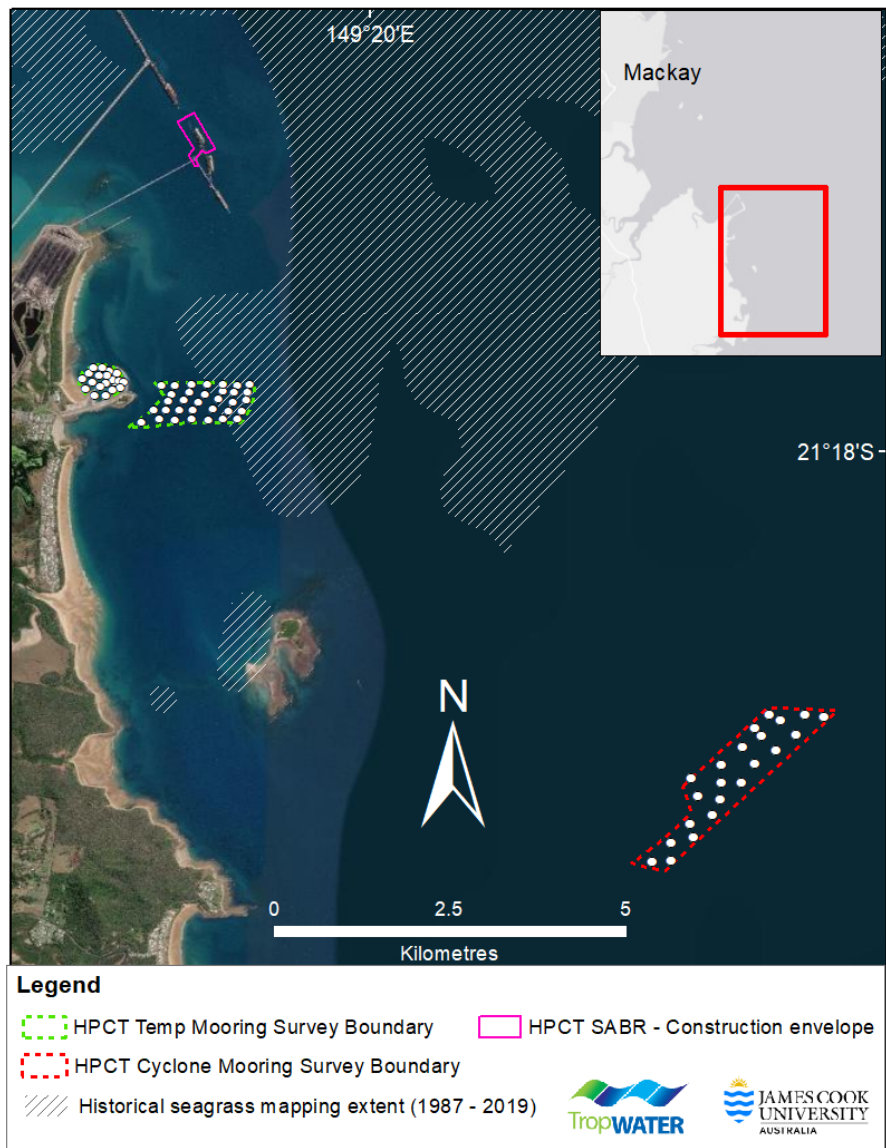
**Figure 3.** Sampling sites for marine macrophyte assessment at the inshore temporary mooring grounds and the offshore cyclone mooring grounds in October 2020.

Marine macrophyte surveys in the area of interest (Figure 1) were conducted on the 10<sup>th</sup> October 2020 for inshore areas (temporary moorings) and on the 12<sup>th</sup> October 2020 for offshore areas (cyclone moorings). Favourable weather and sea state conditions provided excellent water visibility for the assessment of benthic habitats using a live-feed, remote camera. Fifty three (53) sites were assessed during the survey of the proposed temporary mooring grounds with 3 separate camera drops at each site, making a total of one hundred and fifty nine (159) camera drops (Figure 3). More specifically, within the HTTH, twenty (20) sites were assessed for marine macrophyte, and just outside of the HTTH, thirty three (33) sites were assessed. A further twenty two (22) sites were assessed using camera towed video along 100 m transects in the offshore area for the proposed cyclone mooring area (Figure 3).

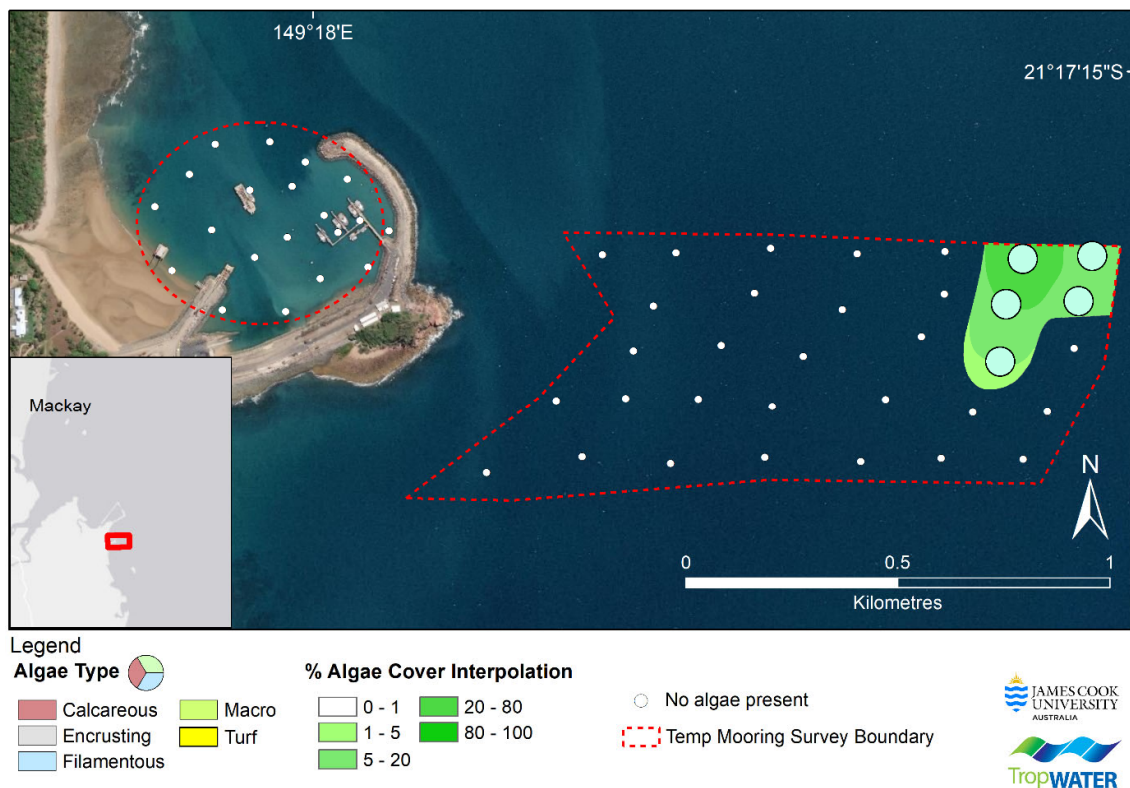
The benthic habitat for the proposed temporary moorings within the HTHH consisted of open substrate of muddy sediments with no marine plants (seagrass or macro-algae) present at any of the assessment sites (Figure 4). The area surveyed for proposed temporary moorings outside of the Tug Harbour also contained predominately open substrate of muddy to sandy sediments and no seagrasses were recorded during the survey. Five of the thirty three sites sampled in this area contained sediment covered in a filamentous algal mat ranging in percent cover from 5 - 40 % (Figure 4). The area covered by the filamentous algal mat (Figure 6a) in the north eastern corner of the survey boundaries was estimated at  $8.1 \pm 2.6$  ha with a low/moderate percent cover of  $19.0 \pm 5.8$  % (Figure 4).

**Figure 4:** Marine macrophyte distribution among temporary mooring areas inside and outside of the Hay Point Tug Harbour. The area was surveyed on 10<sup>th</sup> October 2020 and no seagrass was present.

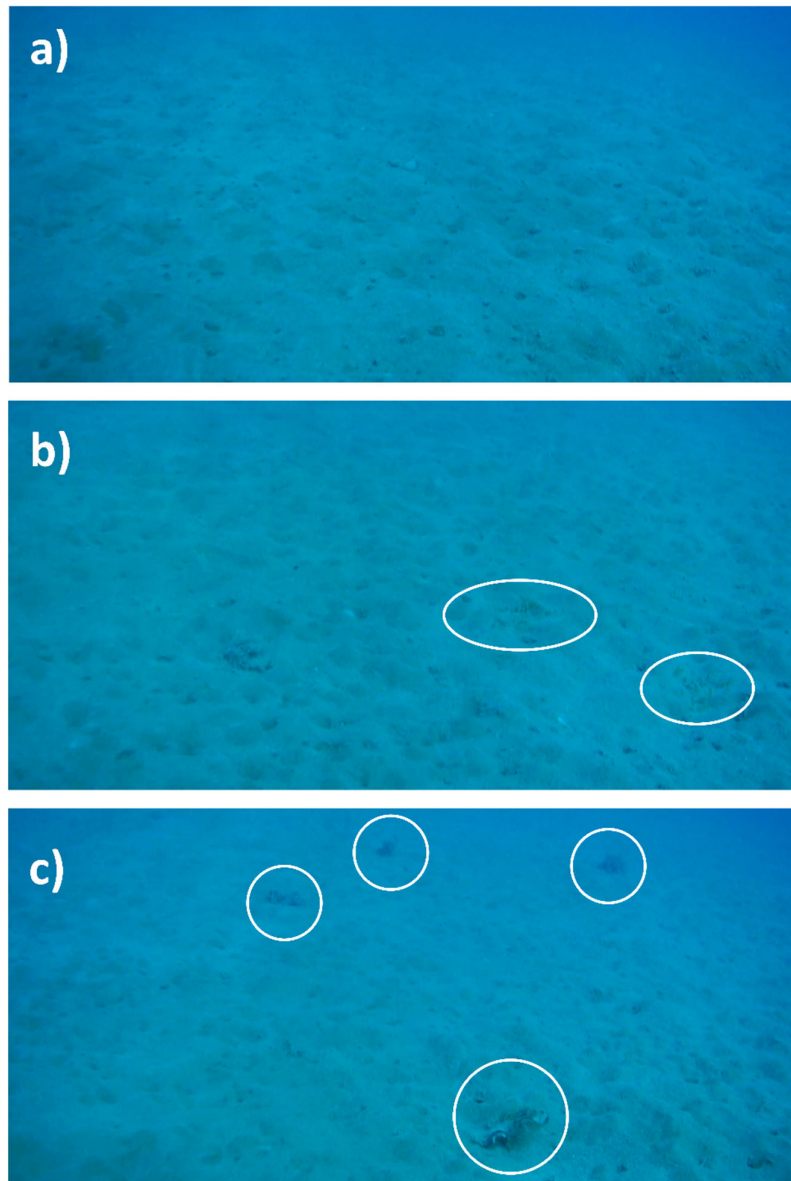
The benthic habitat for the proposed cyclone moorings contained a sparse covering of deep-water seagrass at nine of the twenty two sites surveyed, very low (less than 1 % cover) of marine algae at four sites and a combination of sparse seagrass and very low algae at a further four sites (Figure 5 a, b and c). At the thirteen sites where seagrass was present *Halophila decipiens* was the dominant species with one site also containing *Halophila spinulosa* (Figure 6b & c). The area of the seagrass

Figure 5: Landscape views of the offshore cyclone mooring area showing benthic habitat seen during the survey including a) open sandy substrate b) open substrate with patches of seagrass and c) open substrate with isolated macroalgae

The macro-algae present in the offshore cyclone mooring survey area was very low in density (less than 1 % cover) with only one to several small clumps present (see figures 5 and 6) along each 100 m transect. At this level of cover the probability of disturbing any large quantities of macro-algae when installing mooring sites would be negligible.

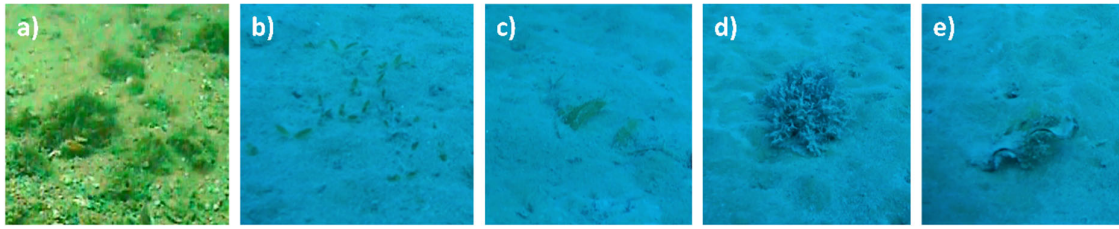
footprint within the cyclone mooring survey boundary was estimated at  $100 \pm 16$  Ha with a very low mean biomass of  $0.008 \pm 0.002$  gDW/m<sup>2</sup> (Figure 7). At the eight sites where marine algae was present macro-algae were the dominant functional group (Figure 6d & e) with rare occurrences of erect calcareous algae and filamentous algae (Figure 8). The cover of marine algae was very low and ranged between 0.05 and 0.3 % among the sites where it was present consisting of one to several small clumps along the 100 m transects (Figure 6d & e; Figure 8). The area of algal distribution within the proposed cyclone mooring boundary was  $53 \pm 13$  Ha (Figure 8). Despite the large area covered by marine macrophytes in the cyclone mooring survey area (seagrass and algae combined - Figure 9) substantial gaps of open substrate remained where cyclone moorings could be located without damage to marine plants.

Figure 6: Major marine macrophyte groups observed during the study including a) filamentous algae, seagrass b) *Halophila decipiens* and c) *Halophila spinulosa* and macro-algae d) and e). The image of the filamentous algae is from a previous survey.

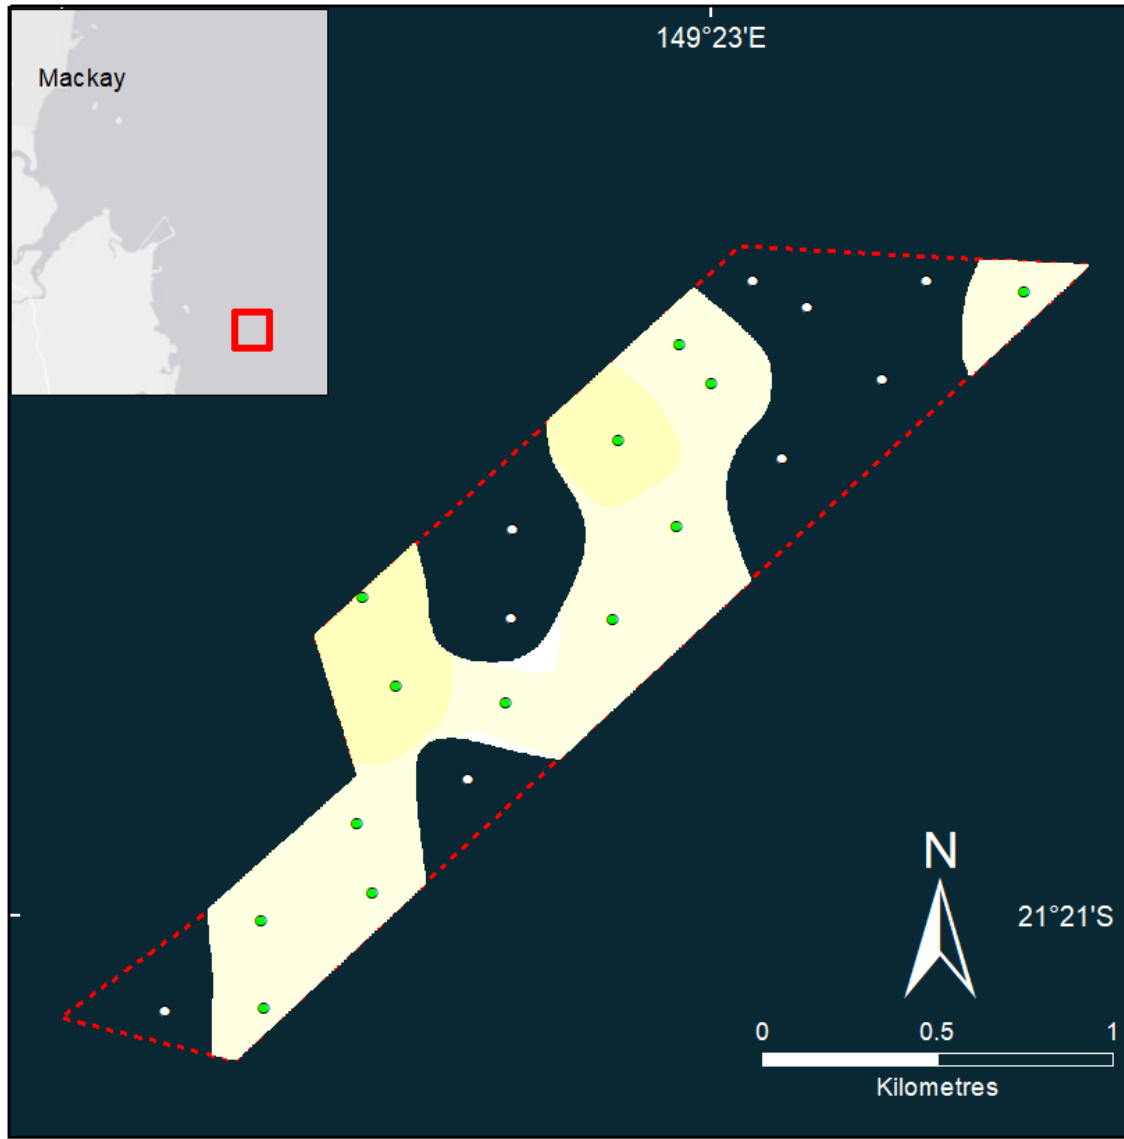
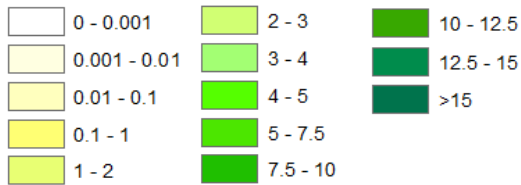
**Figure 7:** Seagrass distribution and density within the cyclone mooring areas offshore from Hay Point. The area was surveyed on 12<sup>th</sup> October 2020.

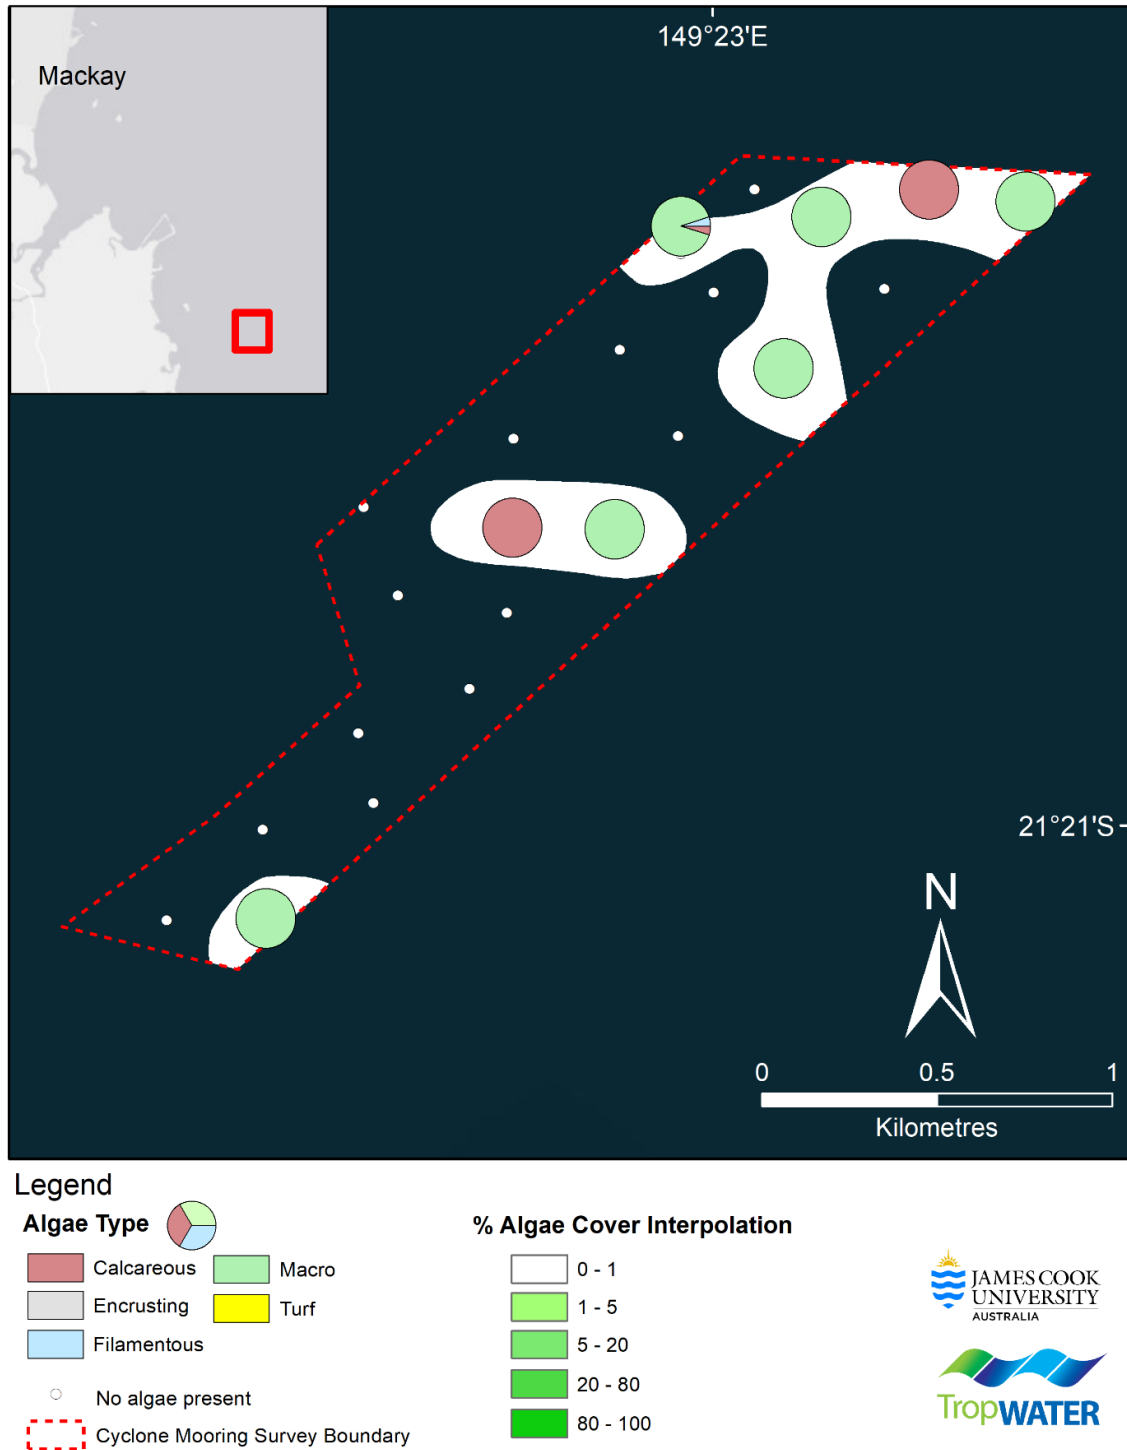
**Figure 8:** Marine algal distribution and cover within the cyclone mooring areas offshore from Hay Point. The area was surveyed on 12<sup>th</sup> October 2020.

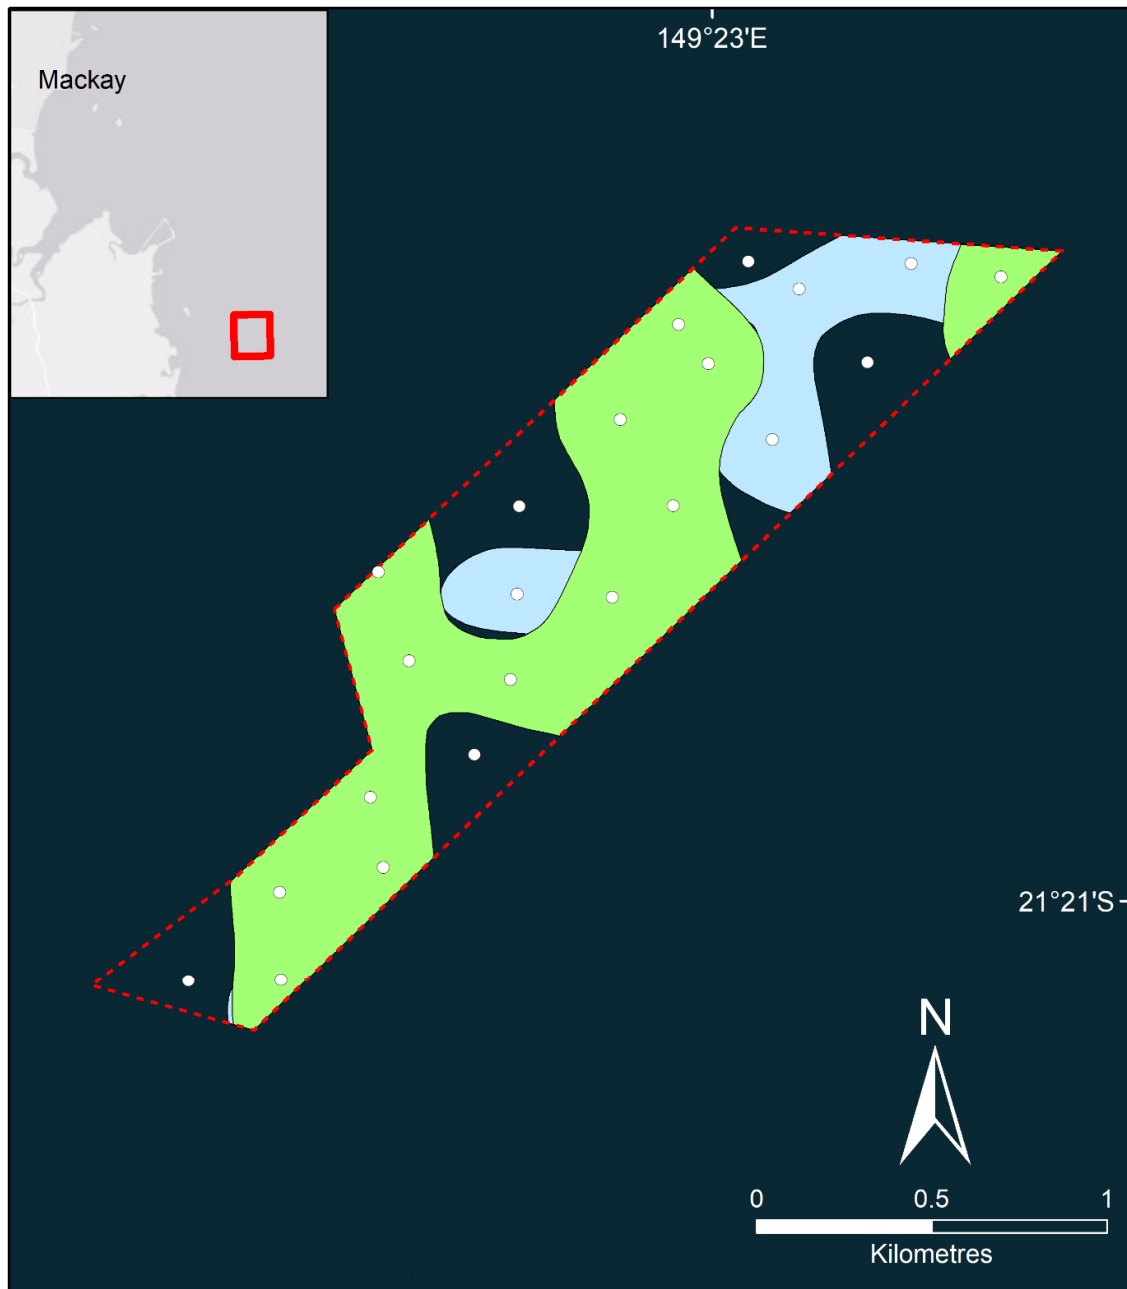
Figure 9: The combined footprint of potential seagrass and algal habitat within the proposed cyclone mooring survey area.
