Green Island Jetty Repairs Seagrass Monitoring Final Report - Sixteen Month Post-Disturbance, October 2021

Report 22/01

Smith TM, McKenna SM, York PH, Rasheed MA

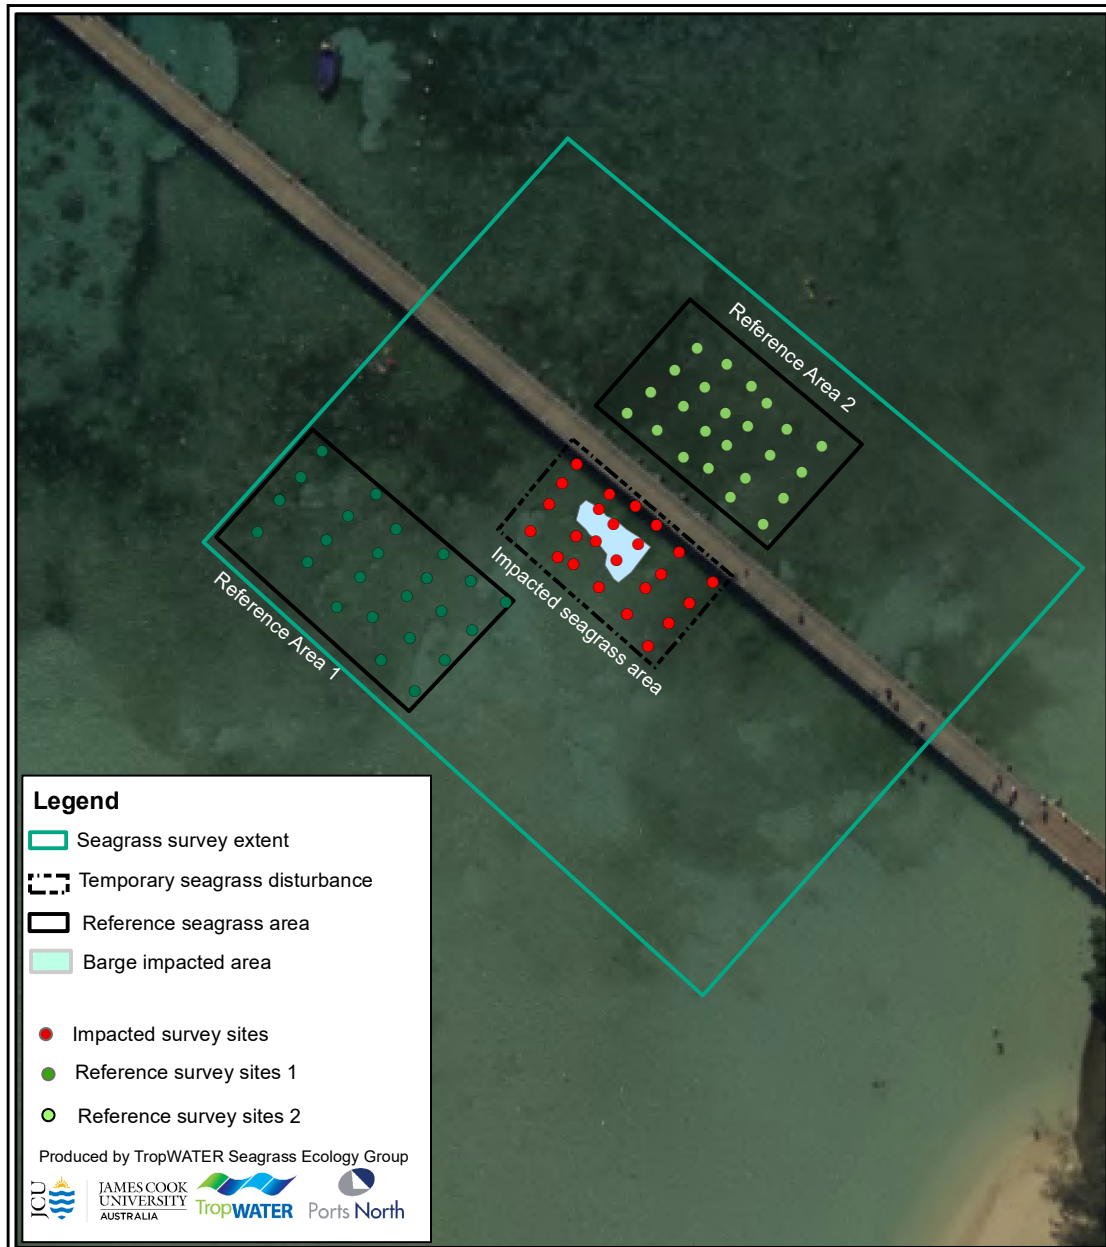
Figure 1. Seagrass survey sites within disturbance and reference blocks three months post-disturbance and areas impacted by the barge and moorings.

The survey design followed those previously used to monitor seagrass at Green Island before (November 2019) and after (June and September 2020, May 2021) jetty repair works. Survey's focused on three monitoring blocks (one area of impact and two reference areas) situated within the initial pre-disturbance survey extent (Figure 1). The disturbance impact block, extending across the barge impact area, and two reference blocks were monitored to assess the impact of the barge on the seagrass meadow and subsequent recovery (Figure 1).

Within the survey blocks, seagrass assessment sites were located at sufficient density to adequately describe the seagrass characteristics (Figure 1). Sampling methods followed those used in the established state-wide seagrass assessment and monitoring program including within Ports North's other ports (see Rasheed et al. 2019; Bryant et al. 2019 for recent reports). These standard methods are based on the JCU TropWATER seagrass program for baseline assessment and monitoring for other areas of Queensland including Cairns, Townsville, Weipa, Gladstone, Abbot Point, Karumba, Mourilyan, Mackay, Clairview and Thursday Island.

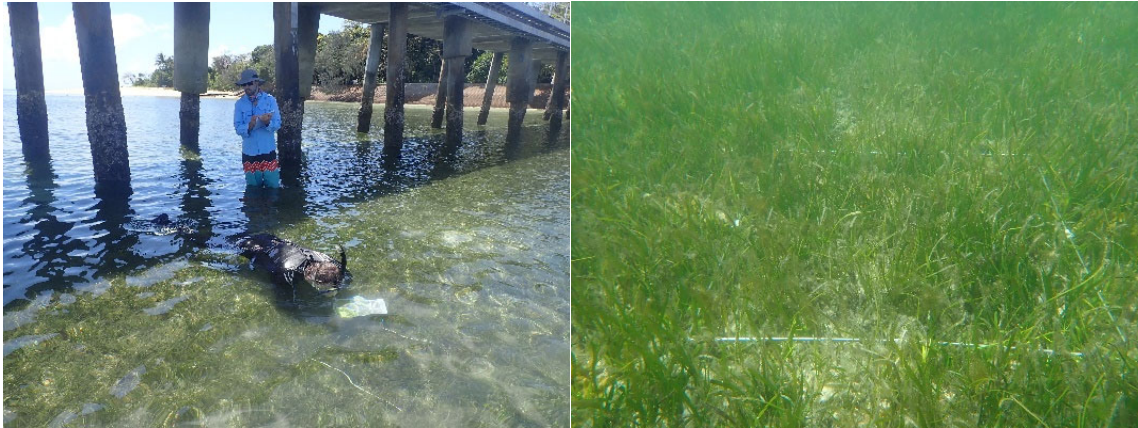
Figure 2. Seagrass habitat assessments.

At each survey site a snorkeler collected data on seagrass and other benthic habitats present in three replicate placements of a 50cm x 50cm quadrat (Figure 2).

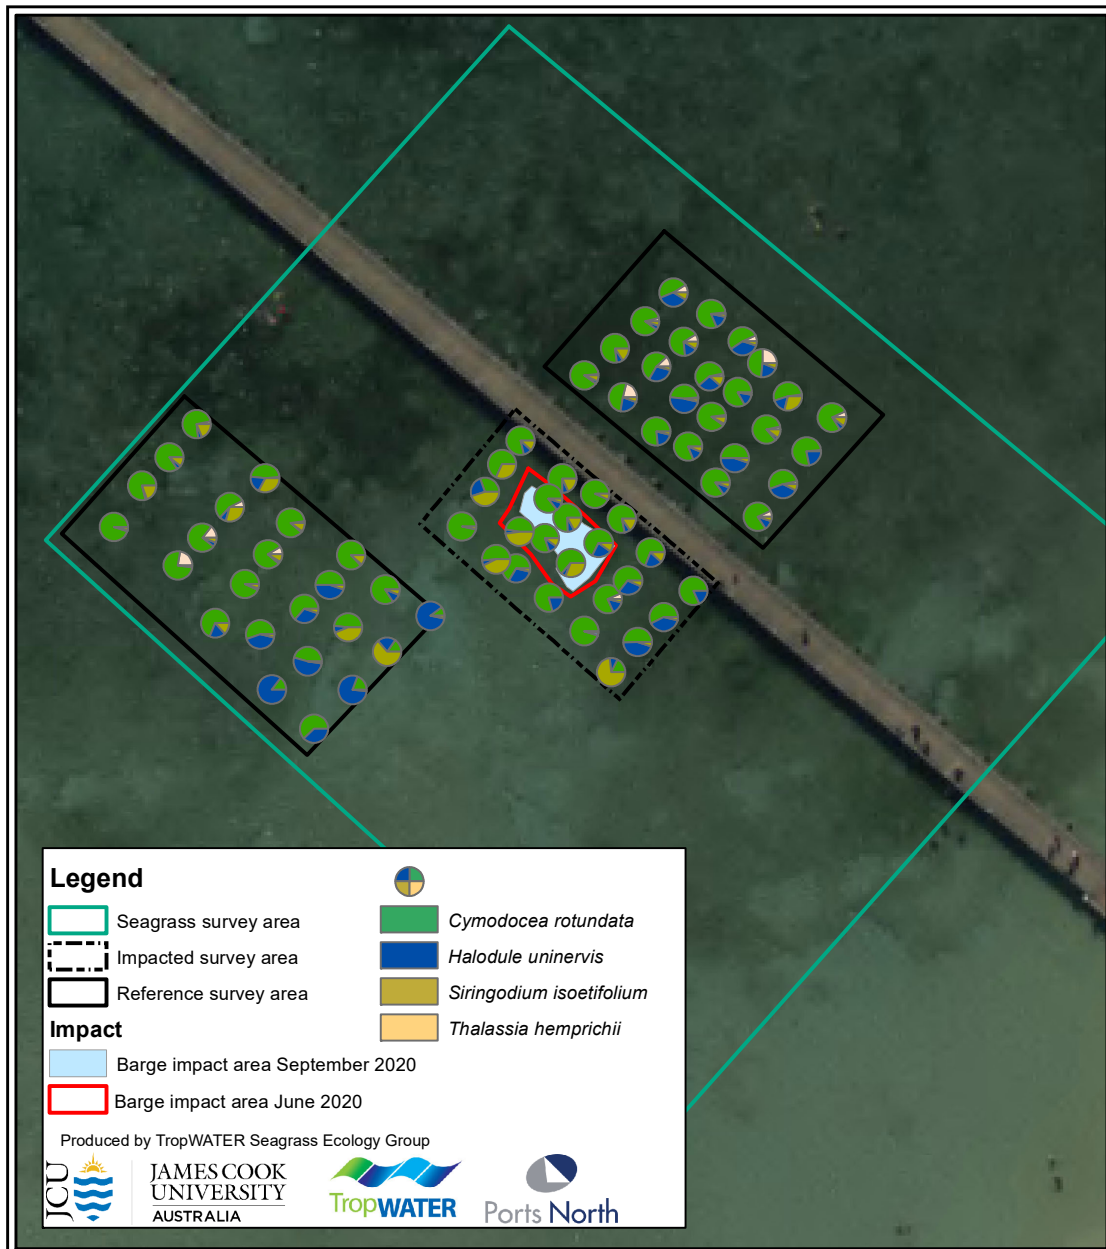
Figure 3. Seagrass species composition at each site within each monitoring block (% of total biomass per species) at the Green Island jetty repair site.

A total of 72 seagrass habitat assessment sites were sampled within the three survey blocks at the Green Island jetty repair site in October 2021 (Figures 1, 3). A total of four seagrass species were identified; *Cymodocea rotundata*, *Halodule uninervis*, *Syringodium isoetifolium* and *Thalassia hemprichii*. Two species, *Halophila ovalis* and *C. serrulata*, have been recorded in previous surveys but were not recorded in this monitoring survey in any of the survey blocks. *Cymodocea rotundata* was the dominant species while *T. hemprichii* was the least common (Figure 3). The composition and biomass of seagrass in the survey area was similar to that of previous surveys of the larger seagrass meadow (Mellors et al. 1993, Rasheed 2000; 2004).

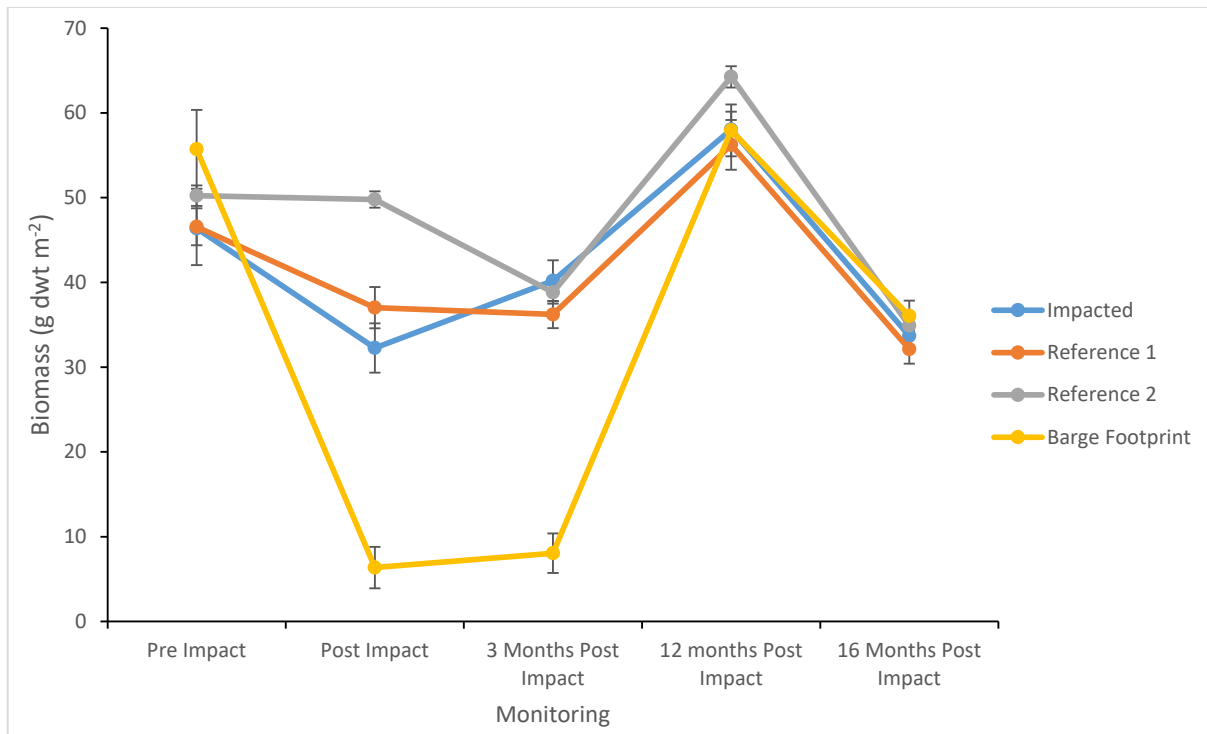
The area of seagrass impacted by the barge during the jetty repairs was indistinguishable from the surrounding meadow 16 months after the initial impact (Figure 4, 5). There was no difference in biomass within the impacted area relative to the reference blocks or visible impacts of the barge in this survey (Figure 4, 5). Immediately after the barge removal (June 2020) there was a distinct 10.0 x 5.5m (50 m²) footprint of absent or very low seagrass cover. Seagrass had begun to re-colonise the area three months after the barge had been removed (September 2020) and the area of absent or very low seagrass biomass had retracted to 29m² (Figure 4, 5, 6). After 12 months (May 2021) there was no visible impact of the barge or the denuded seagrass area as biomass in the impacted area returned to reference and pre-impact levels indicating the seagrass had recovered (Figure 4, 5, 6). Maintenance of similar seagrass biomass across impacted and reference blocks in this survey show that the seagrass has fully recovered and there are no lingering effects of the seagrass loss caused by the barge during the jetty works.

Figure 4. Seagrass biomass (mean \pm SE) at each monitoring area and within the barge footprint during each monitoring survey.

Seagrass biomass across all monitoring blocks was lowest in this survey (October 2021, 16 months post-impact) compared to the previous surveys (Figure 4, 5). Biomass in the reference blocks also declined in September 2020 (three months post impact) relative to the first two surveys. These declines maybe related to broad scale seasonal variations in seagrass growth and condition. On Green Island, seagrass biomass peaks in December-January and is lowest in June-August as a function of changing light and temperature conditions (Mellors et al. 1993, Rasheed 2004). Biomass is generally lowest in August and begins to increase in September and October until peaking later in summer (Mellors et al. 1993, Rasheed 2004). Low biomass recorded in September/October in this survey is consistent with these seasonal changes. Grazing from turtle and other marine herbivores can also regulate seagrass biomass on Green Island causing localised seagrass declines (Scott et al. 2020). Evidence of seagrass herbivory was recorded during this survey (Figure 6D) and could be contributing to lower biomass across the survey blocks during the final survey.
