Port of Karumba long-term annual seagrass monitoring 2022

January 2023 | Report No. 23/1

Centre for Tropical Water & Aquatic Ecosystem Research (TropWATER) James Cook University

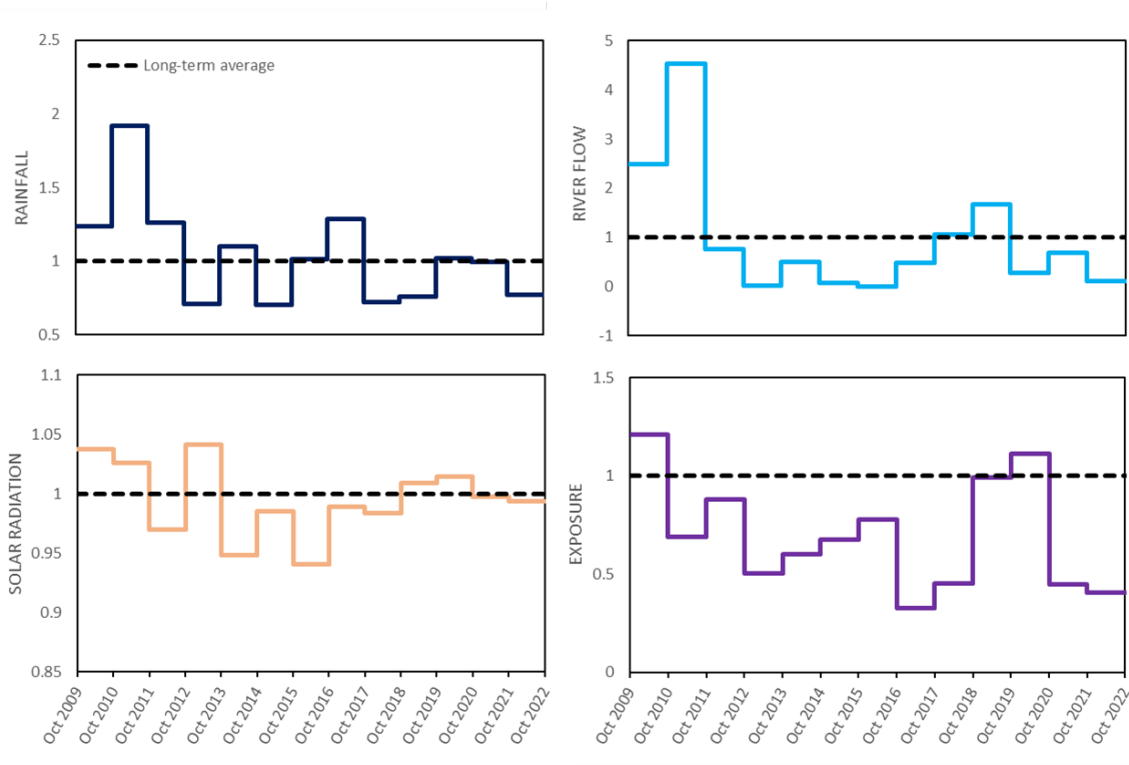
FIGURE 2. CHANGE IN CLIMATE VARIABLES AS A PROPORTION OF THE LONG-TERM AVERAGE IN KARUMBA. SEE SECTION 3.5 FOR DETAILED CLIMATE DATA.

Favourable environmental conditions for seagrass growth in 2022 have allowed continued improvement in seagrass condition, with rainfall, river flow and the amount of daytime air exposure of the meadow all below the long-term average in 2022 (Figure 2). The maintenance of very good meadow condition and presence of the below-ground seed bank in 2022, means Karumba seagrasses have some resilience leading into 2023 and an ability to recover via the seed bank if faced with large scale climate or anthropogenic impacts.

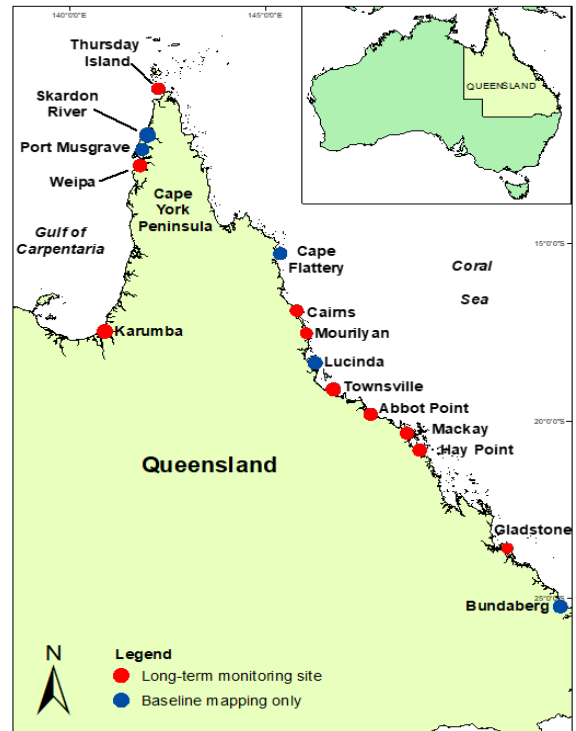
FIGURE 3. LOCATION OF QUEENSLAND PORT SEAGRASS ASSESSMENT SITES.

A long-term seagrass monitoring and assessment program has been established in the majority of Queensland’s commercial ports. The program was developed by James Cook University’s Centre for Tropical Water & Aquatic Ecosystem Research (TropWATER) in partnership with the various Queensland port authorities. While each location is funded separately, a common methodology and rationale is used, providing a network of seagrass monitoring locations throughout Queensland (Figure 3).

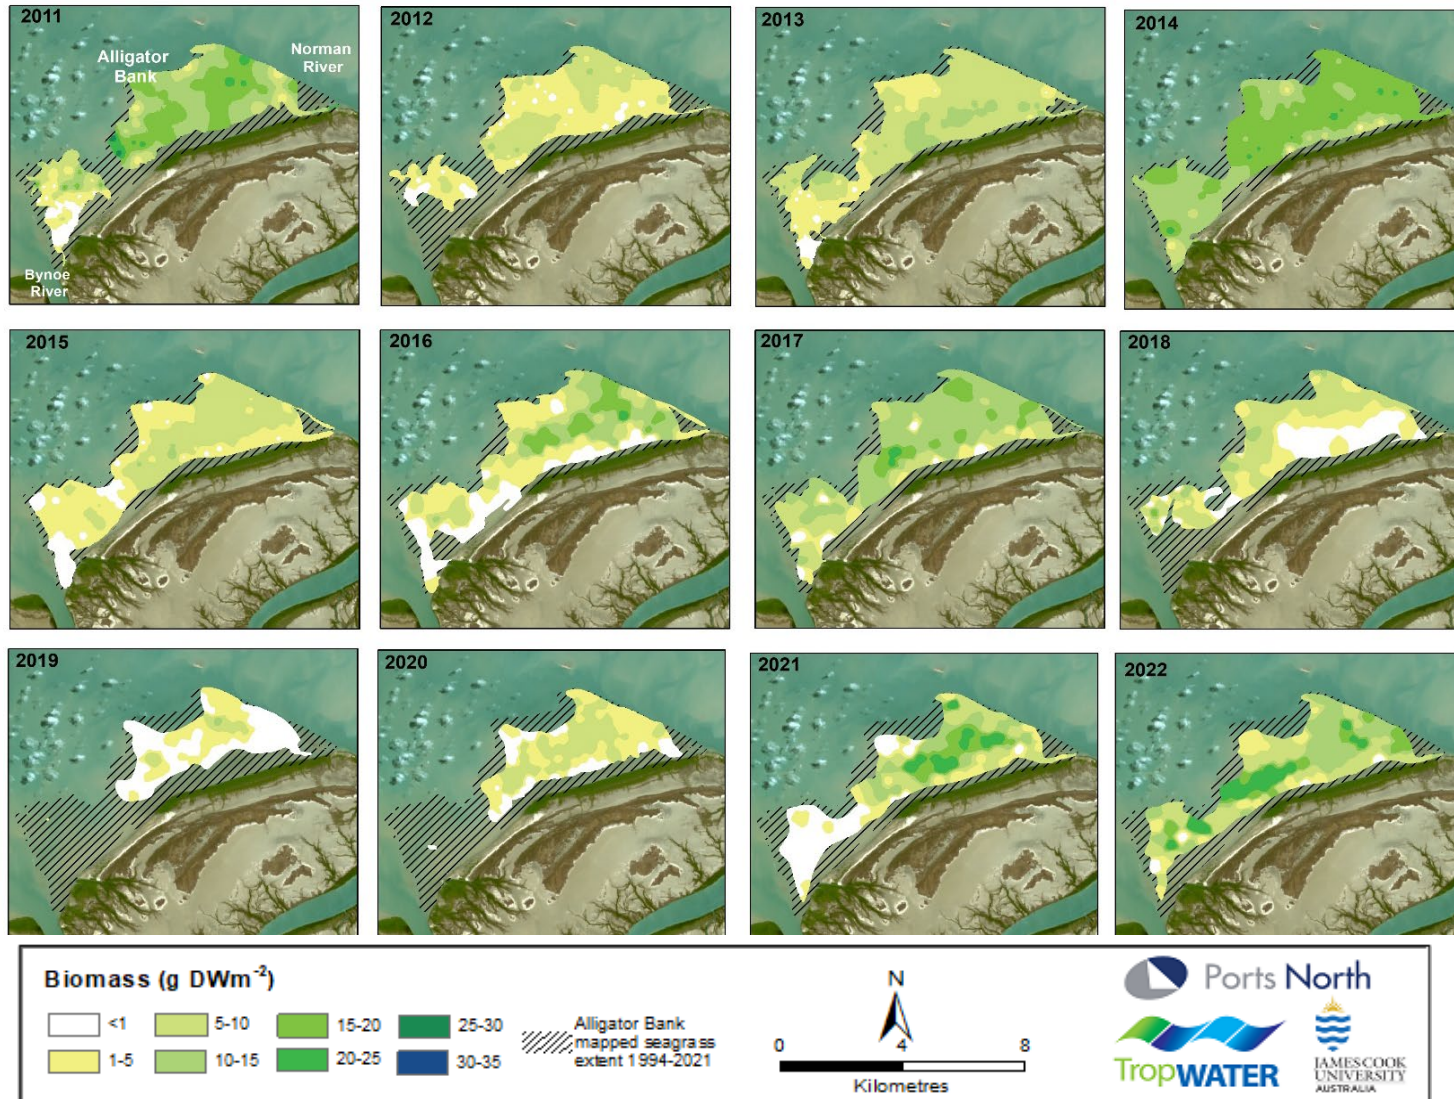
FIGURE 8. BIOMASS AND AREA CHANGE IN THE ALLIGATOR BANK MONITORING MEADOW, 2011 TO 2022.

Above-ground biomass remained in very good condition for the second year in a row in 2022 (Figure 7). Average meadow above-ground biomass increased by 4.6 g DW m⁻² from 2021 to 2022 and was the third highest recorded since monitoring began (Figure 7). This trend continues the improvement in above-ground biomass from 2020 onwards, from the low levels in 2019. This increase in above-ground biomass occurred throughout the expanded meadow area on Alligator Bank documented in 2021 (Figure 8).

Seagrass meadow area increased by 32 ha in 2022, maintaining the large improvement seen in 2021 and the very good condition documented in this survey (Figure 7). There have been some small increases in the seagrass meadow boundary in 2022 and no significant areas of loss (Figure 8).

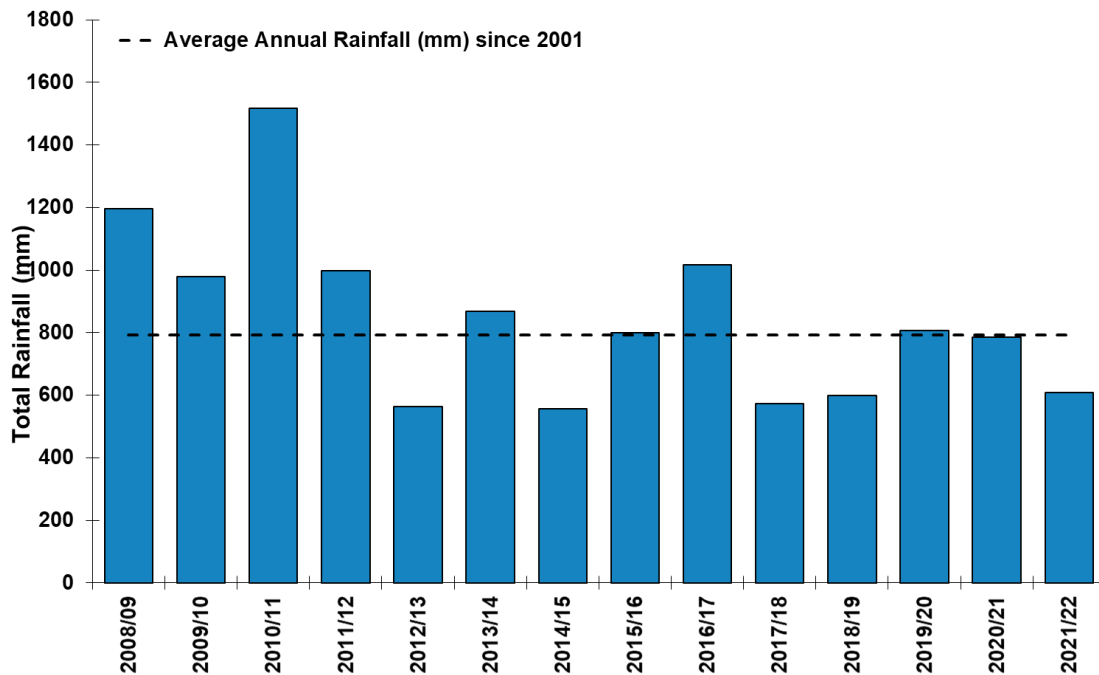
Total annual rainfall for the Normanton area in the twelve months prior to the November 2022 survey was 609 mm, this was below the average annual rainfall for the area (Figure 12). The majority of the monthly rainfall during this 12 month period was below average, with only November 2021 and May 2022 recording slightly above average rainfall (Figure 13). During the survey month there was 41.3 mm of rain, and only 13.1 mm fell in the three months leading up to the survey (Figure 13).

FIGURE 12. TOTAL ANNUAL RAINFALL (MM) RECORDED AT NORMANTON AIRPORT, 2008/09 – 2021/22, IN EACH 12 MONTHS PRIOR TO SEAGRASS SURVEY.

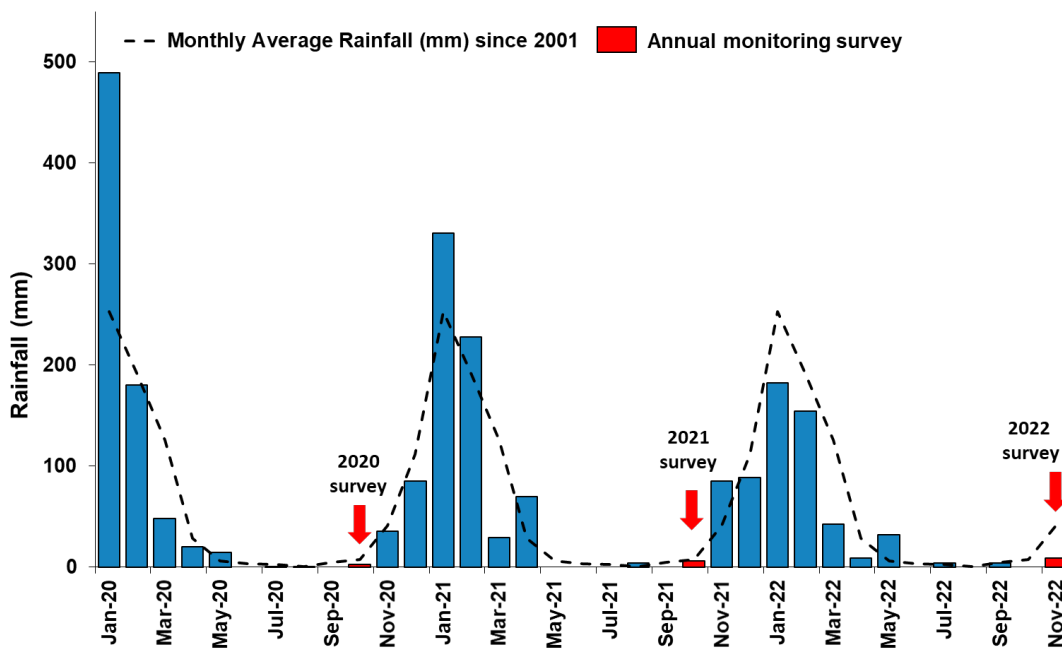
FIGURE 13. TOTAL MONTHLY RAINFALL (MM) RECORDED AT NORMANTON AIRPORT, JANUARY 2020 - NOVEMBER 2022.

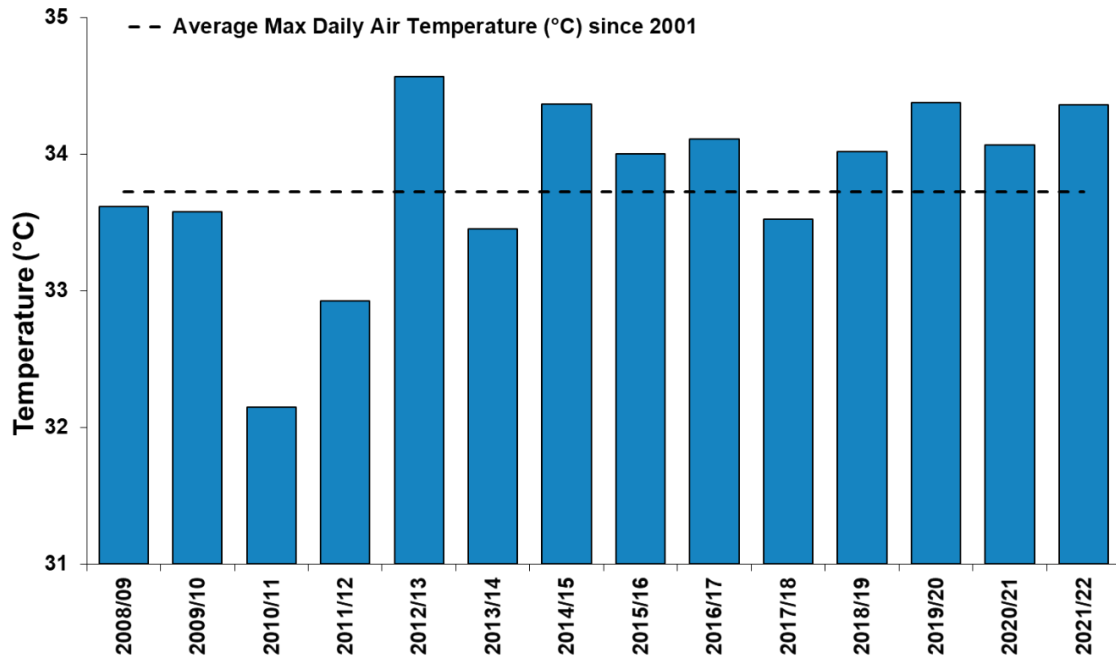
Air temperature was above-average in the region in 2021/22, with a mean annual daily maximum air temperature of 34.4°C (Figure 16). Monthly average maximum daily temperatures were also above average for most of the 12 months prior to the survey with the exception of November and December in 2021 and July and November 2022 (Figure 17).

FIGURE 16. MEAN MAXIMUM DAILY AIR TEMPERATURE (°C) RECORDED AT NORMANTON AIRPORT, 2008/09 - 2021/22. TWELVE MONTH YEAR (2020/21) IS TWELVE MONTHS PRIOR TO SURVEY.

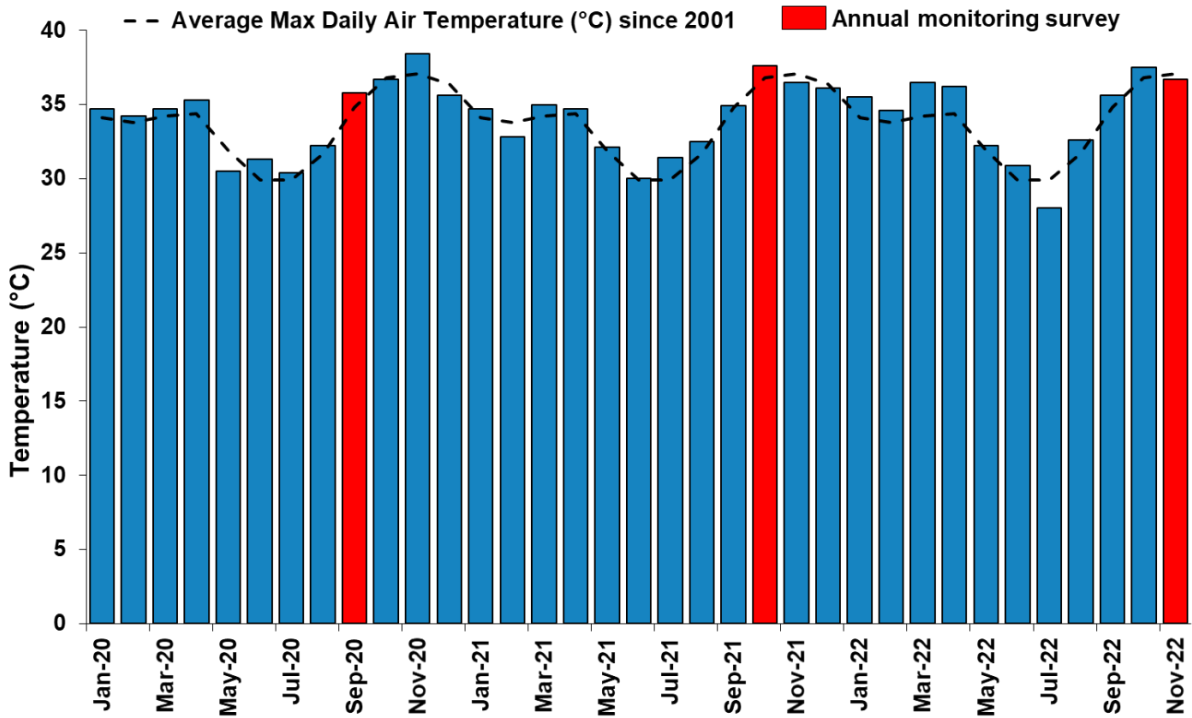
FIGURE 17. MONTHLY MEAN MAXIMUM DAILY AIR TEMPERATURE (°C) RECORDED AT NORMANTON AIRPORT, JANUARY 2020 – NOVEMBER 2022.

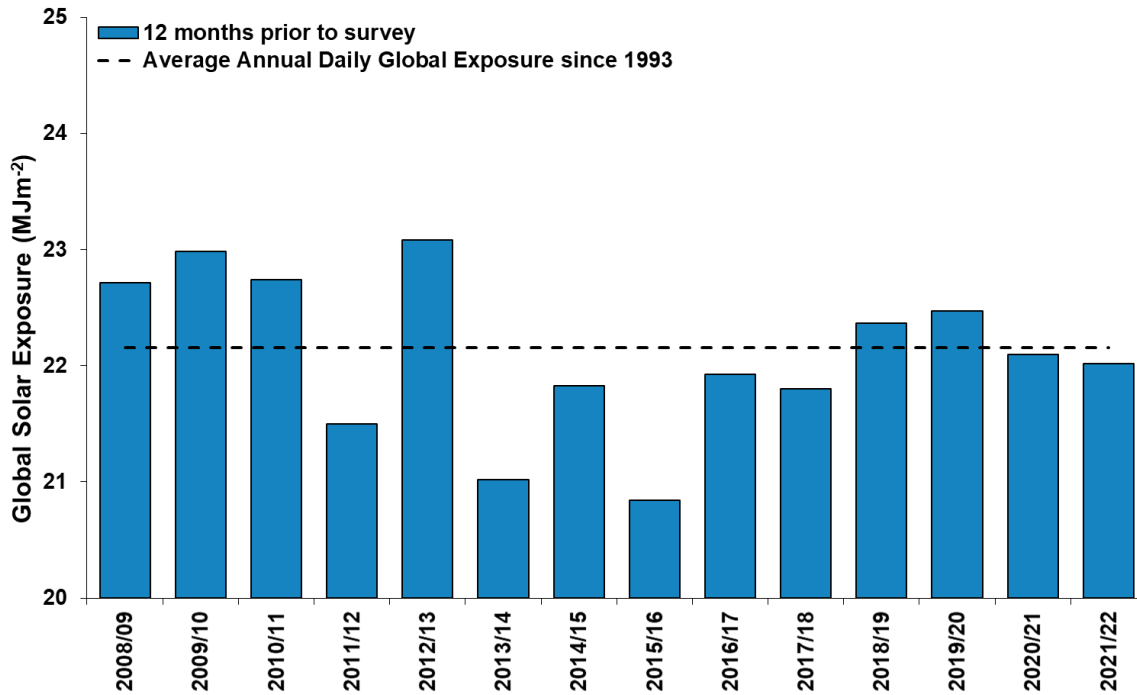
Daily global solar exposure is a measure of the total amount of solar energy falling on a horizontal surface in one day. Values are generally highest in clear sun conditions during spring/summer and lowest during winter. Global solar exposure in the Normanton area was slightly below-average in 2021/22 at 22.0 MJ m⁻² (MegaJoules m⁻²) (Figure 18), with solar exposure close to or below average for most of the 12 months prior to the survey (Figure 19).

FIGURE 18. MEAN DAILY GLOBAL EXPOSURE (MEGAJOULES M⁻²) RECORDED AT NORMANTON AIRPORT, 2008/09 – 2021/22. TWELVE MONTH YEAR (2020/21) IS TWELVE MONTHS PRIOR TO SURVEY.
