TSRA Groundwater Monitoring: Final Report 2022

Report No. 22/46

TSRA Groundwater Monitoring: Final Report 2022, incorporating Technical Report 2021.

A Report for Torres Strait Regional Authority

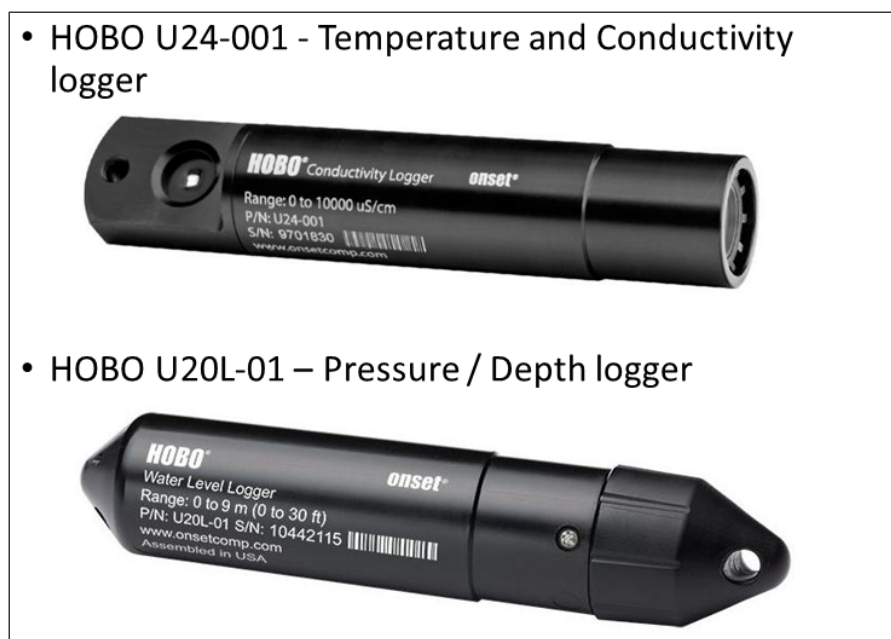
Figure 7: HOBO dataloggers used to measure conductivity (salinity) and water depth in the groundwater wells.

Each well was equipped with a pair of dataloggers to record depth, temperature, and electrical conductivity of the well water. Each pair consisted of a HOBO U20L-01 Water Level datalogger and a HOBO U24-001 Fresh Water Conductivity datalogger (Onset Computer Corporation, Massachusetts USA) (Figure 7). The data loggers were affixed inside the well with a length of stainless-steel wire or nylon cord at a set depth.

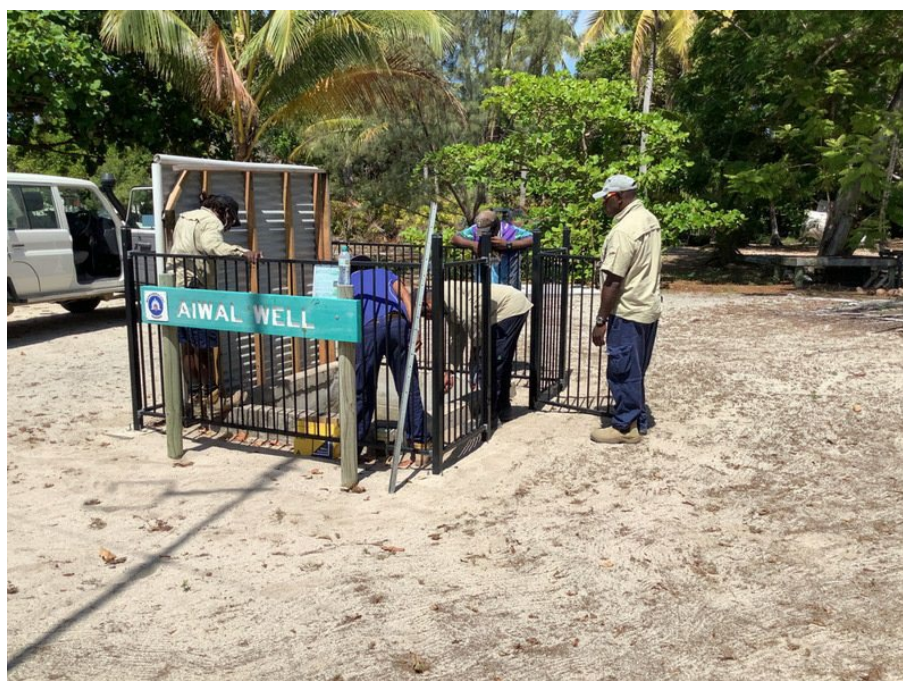
Figure 16: Warraber’s Aiwal Well is a concrete lined square well with a total depth of 2.89 m bgl.

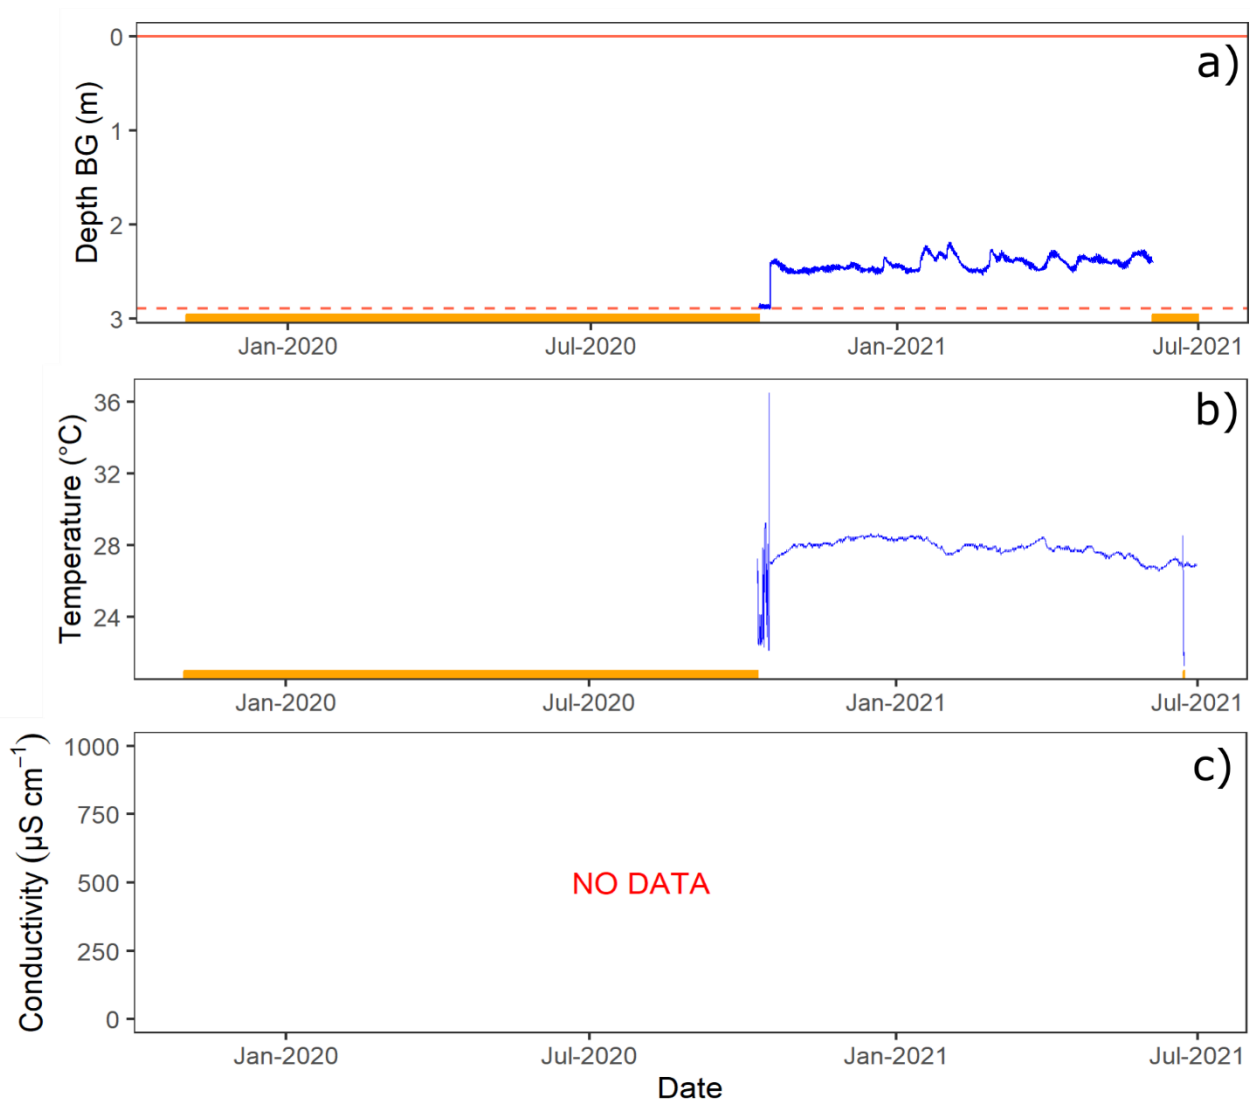
Logger data downloaded from this well covered the period from 10/10/2020 to 03/06/2021 (Figure 17). The depth logger recorded data between 10/10/2020 and 16/10/2020 which appears to be a period prior to the logger’s installation in the well. The temperature sensor showed high daily range which indicates the logger was out of the water for that period. Inspection of the logger data indicates that the logger was installed in

the well on the afternoon of 17/10/2021. The logger recorded data covering the period 17/10/2021 to 03/06/2021. Over that period the groundwater depth ranged from 2.2 to 2.5 m bgl and groundwater temperature ranged from 26.5 to 28.5 °C. No data was returned from the conductivity logger.

Figure 17: Data recorded by submerged dataloggers at Warraber’s Aiwai Well. a) water depth below ground level. The red horizontal line at 0 m indicates ground level, red dashed line represents the bottom of the well. b) water temperature, and c) Electrical conductivity. Conductivity values are reported in microsiemens per centimeter ($\mu\text{S cm}^{-1}$). The orange strip at the bottom of each panel indicates periods of missing data.

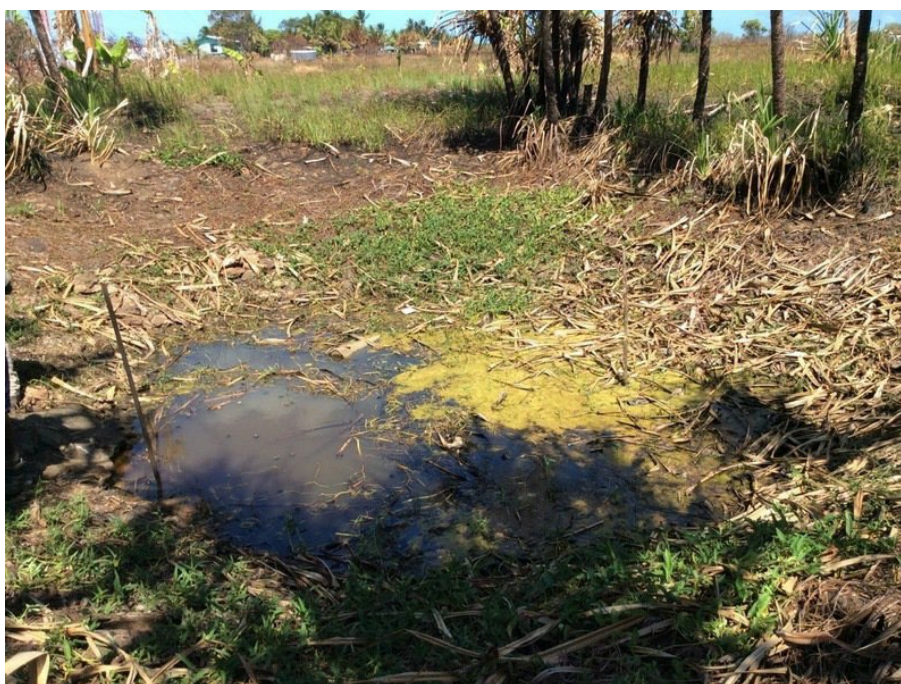
Figure 19: Buthu May Well on Saibai Island is a traditional hand dug well which historically supplied water to nearby community gardens.

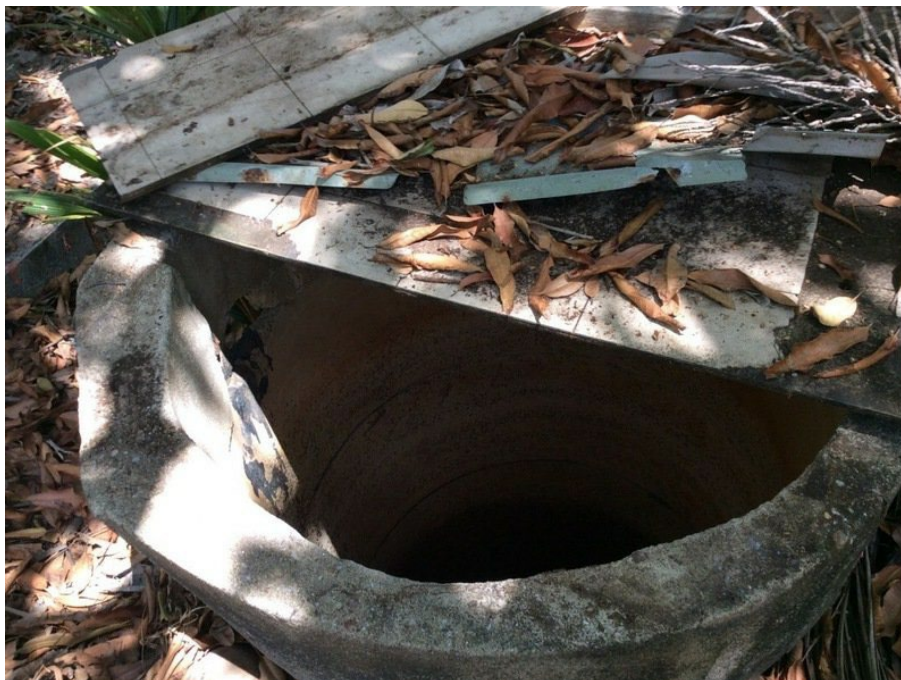
Figure 21: St Paul's Kurrsarr Well is a concrete lined circular well located adjacent to the community gardens. The well has a total depth of 2.22 m bgl.

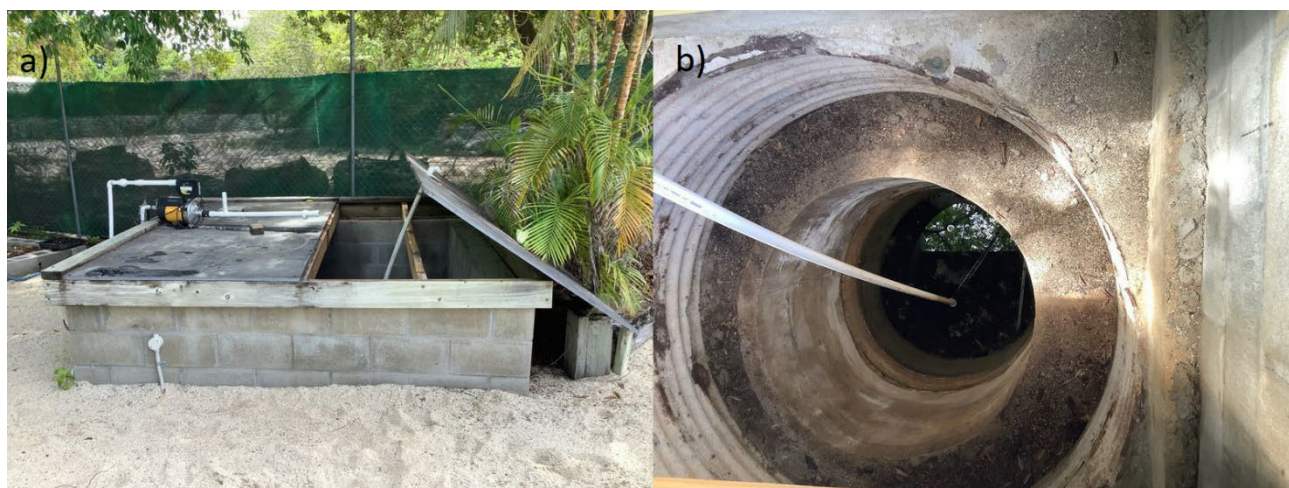
Figure 23: Mother's Well is a concrete lined circular well located on Masig Island at the Mothers Well Nursery. The well has a total depth of 6.0 m bgl.

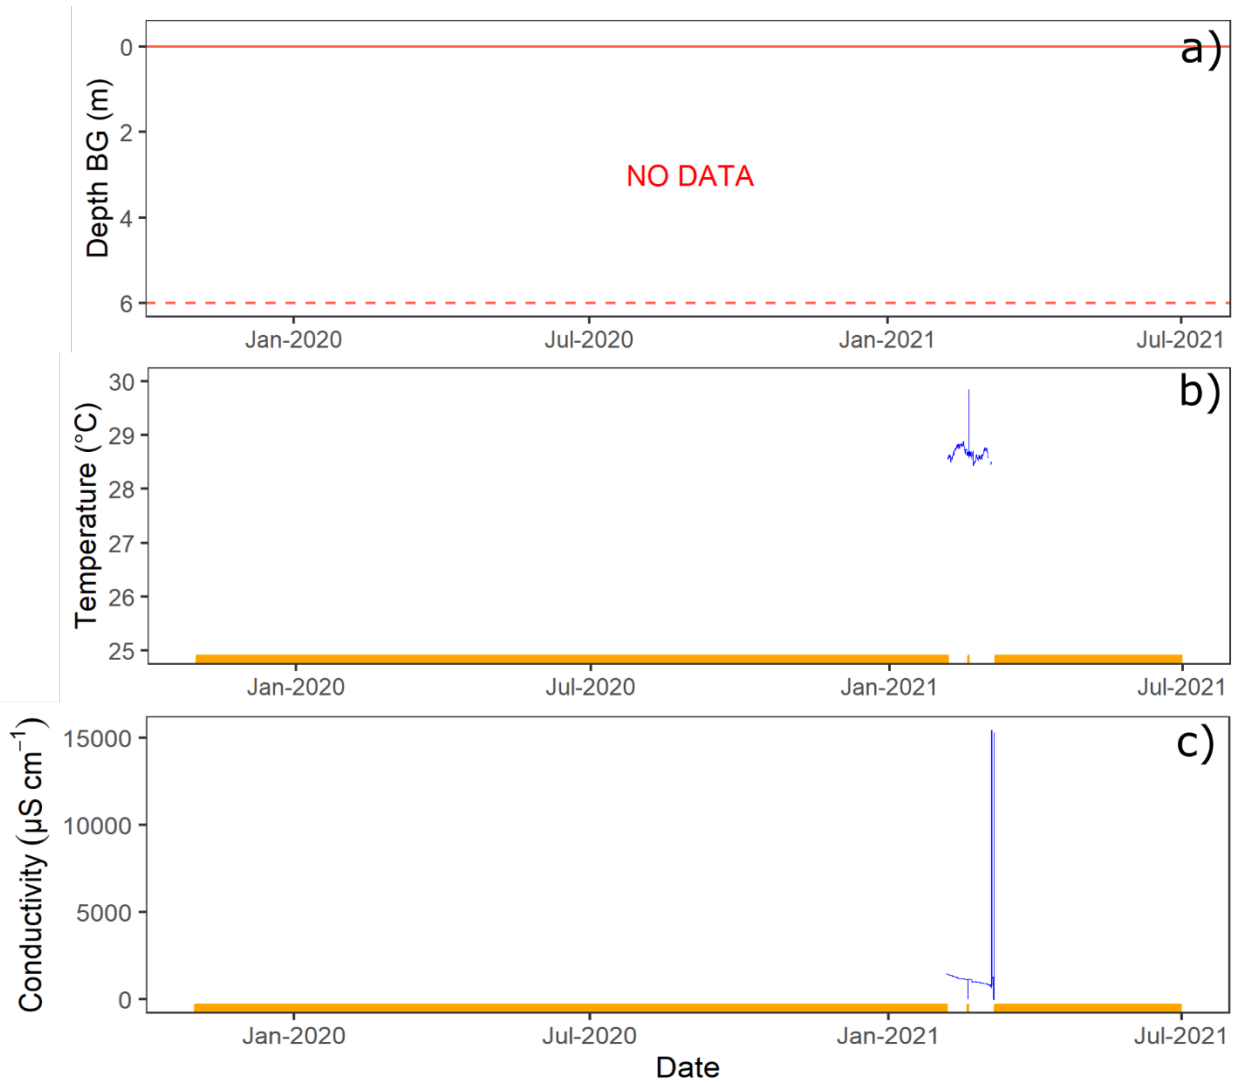
The data recorded by submerged dataloggers at Masig Island's Mother's Well is presented in Figure 24. Logger data downloaded from this well covered the period from 06/02/2021 to 18/02/2021. There was no data recovered from the depth logger. A short period of data was recovered from conductivity logger (06/02/2021 to 18/02/2021). The logger initially recorded a conductivity value of approximately $1500 \mu\text{S cm}^{-1}$ at the start of the deployment then steadily declined to approximately $1200 \mu\text{S cm}^{-1}$ over the following days. Conductivity values in this range are typical of freshwater. Temperature ranged from 28.5 to 29 °c throughout the period.

Figure 24: Data recorded by submerged dataloggers at Masig Island’s Mother’s Well. a) water depth below ground level. The red horizontal line at 0 m indicates ground level, red dashed line represents the bottom of the well. b) water temperature, and c) Electrical conductivity. Conductivity values are reported in microsiemens per centimeter ($\mu\text{S cm}^{-1}$). The orange strip at the bottom of each panel indicates periods of missing data.

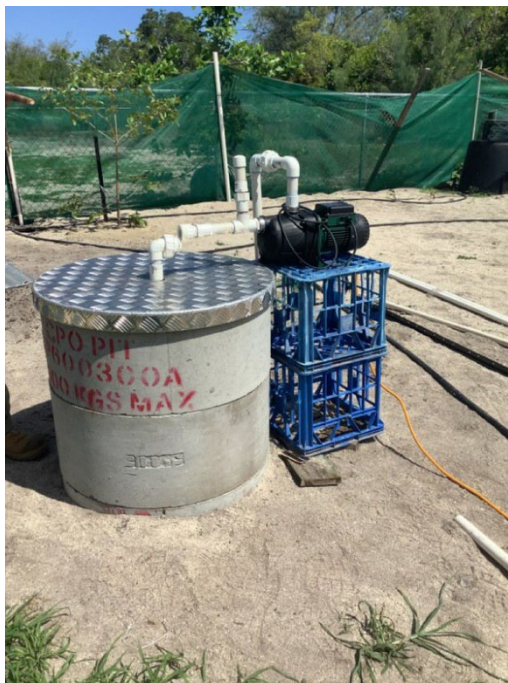
Thelma Billy Well was established as a sampling site in December 2020 (Figure 25). The rangers commented on the fulcrum form that “the water is low and quality is dirty”. Well dimensions were not recorded on the fulcrum form.

Figure 25: Thelma Billy Well is a concrete lined circular well located on Masig Island.

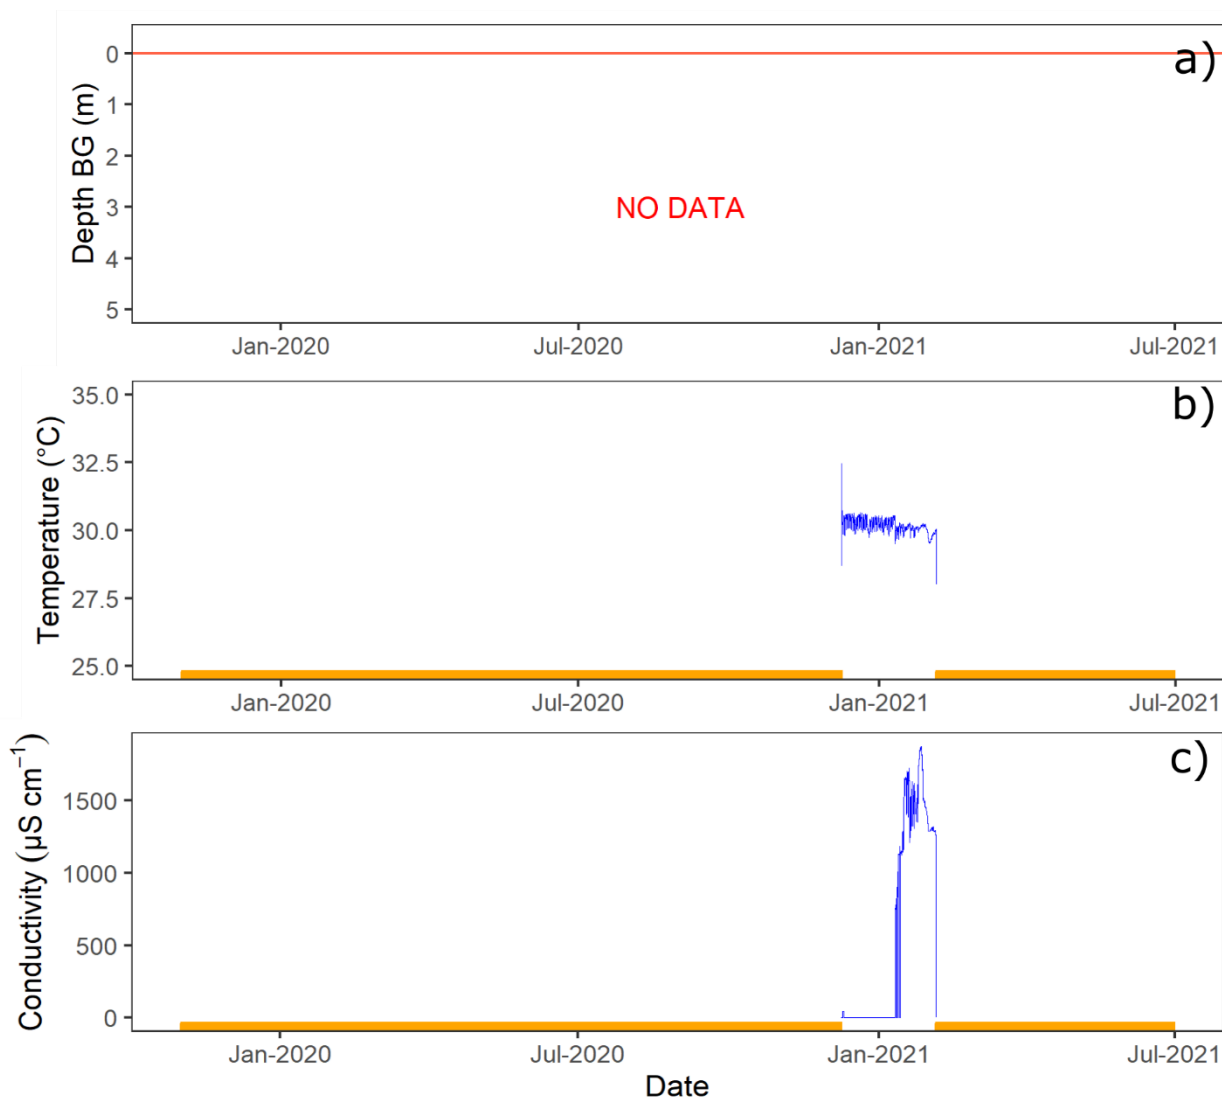
A short period of data was recovered from conductivity logger (09/12/2020 to 02/04/2021) (Figure 26). There was no data recovered from the depth logger. The logger recorded conductivity value of $0 \mu\text{S cm}^{-1}$ for the first month of deployment, indicating that the logger was most probably positioned above water. The conductivity sensor began showing sporadic values from 10/01/2021, and likely coincides with the aquifer filling. The conductivity sensor began to show ‘real’ data from 25/01/2021 in the range of 1500 to 1800 $\mu\text{S cm}^{-1}$. Conductivity values in this range are indicative of freshwater with slightly elevated salts. The temperature sensor also showed patterns typical of the sensor being exposed to air, with larger daily range than expected when submerged. Temperature stabilized from 25/01/2021 and showed groundwater temperature to be in the range of 29.5 to 30.2 °C.

Figure 26: Data recorded by submerged dataloggers at Masig Island’s Thelma Billy Well. a) water depth below ground level. The red horizontal line at 0 m indicates ground level. b) water temperature, and c) Electrical conductivity. Conductivity values are reported in microsiemens per centimeter ($\mu\text{S cm}^{-1}$). The orange strip at the bottom of each panel indicates periods of missing data.

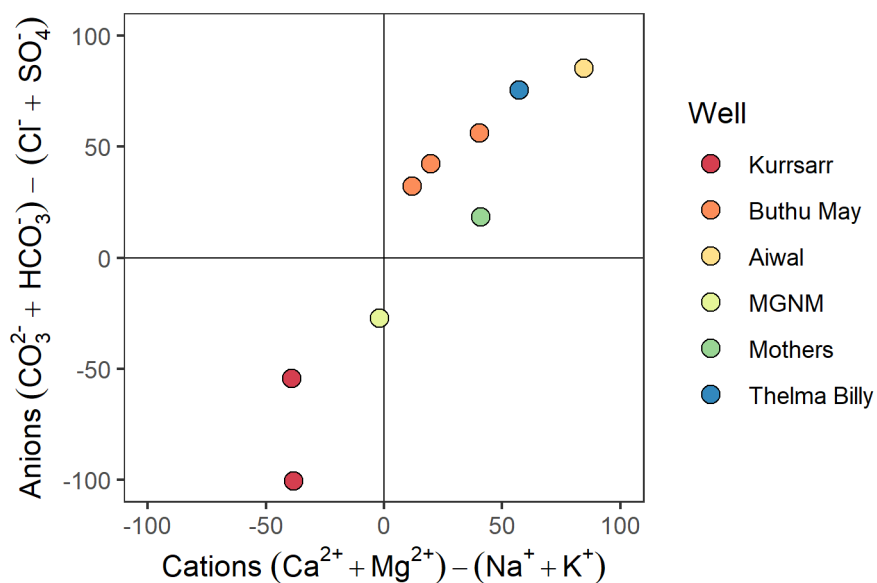
Figure 28: Chadha diagram of water collected from groundwater wells. The x-axis shows the difference in milliequivalent percentages between alkaline earths (calcium and magnesium) and alkali metals (sodium and potassium). The y-axis shows the difference between weak acidic anions (carbonate and bicarbonate) and strong acidic anions (chloride and sulphate).

A Chadha diagram was prepared to further classification of well water based on its hydrochemistry (Figure 28).

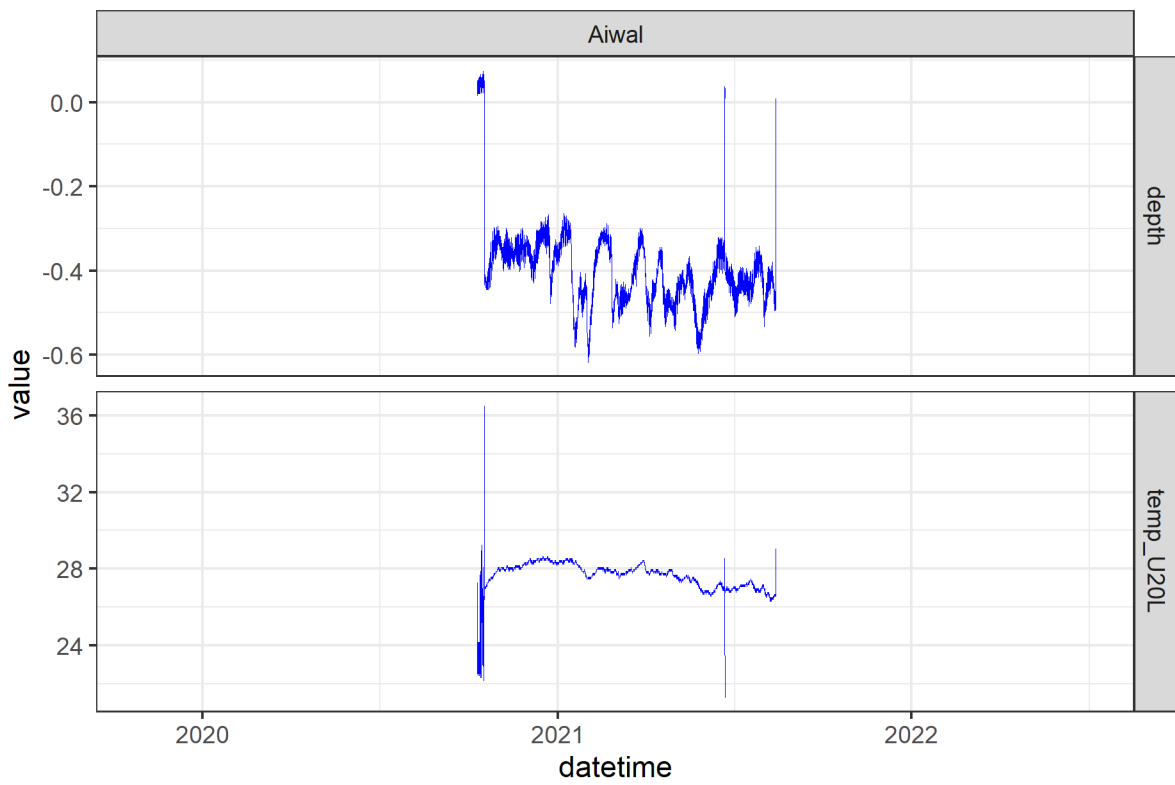
Figure A 1: Depth and temperature from logger data at Aiwai Well on Warraber Islet.

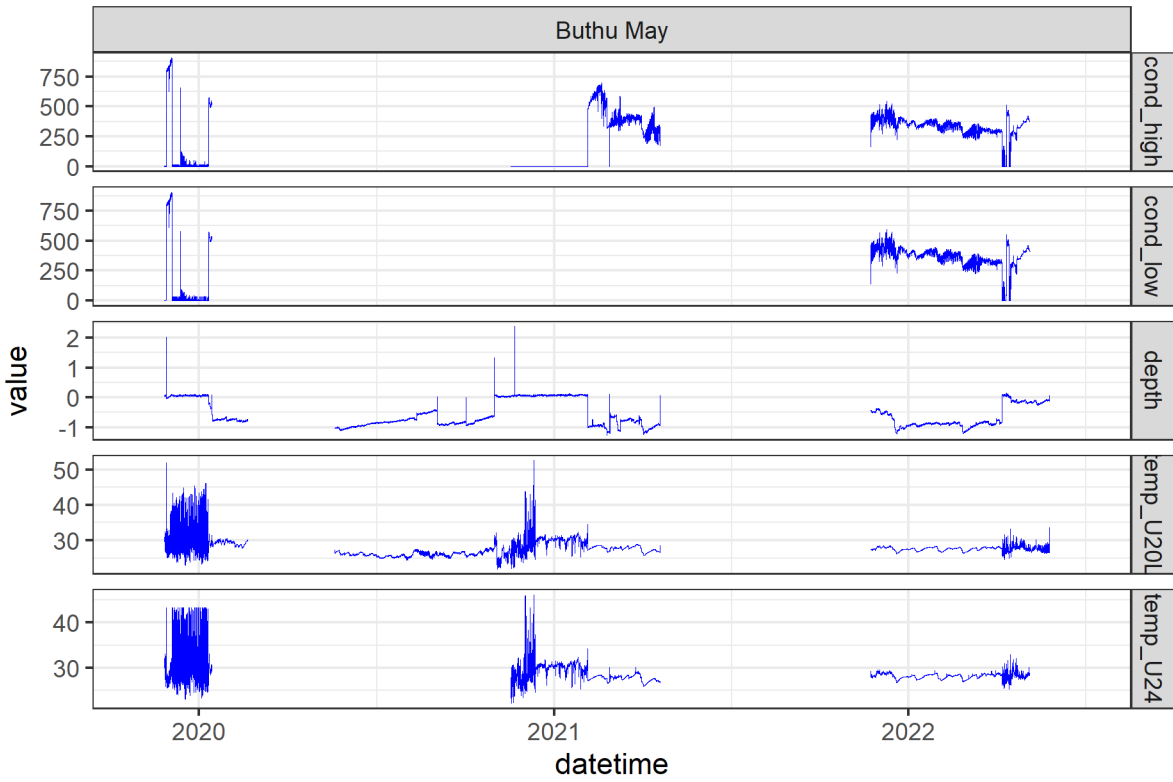
Figure A 2: Conductivity, depth, and temperature at the Buthu May Well on Saibai.

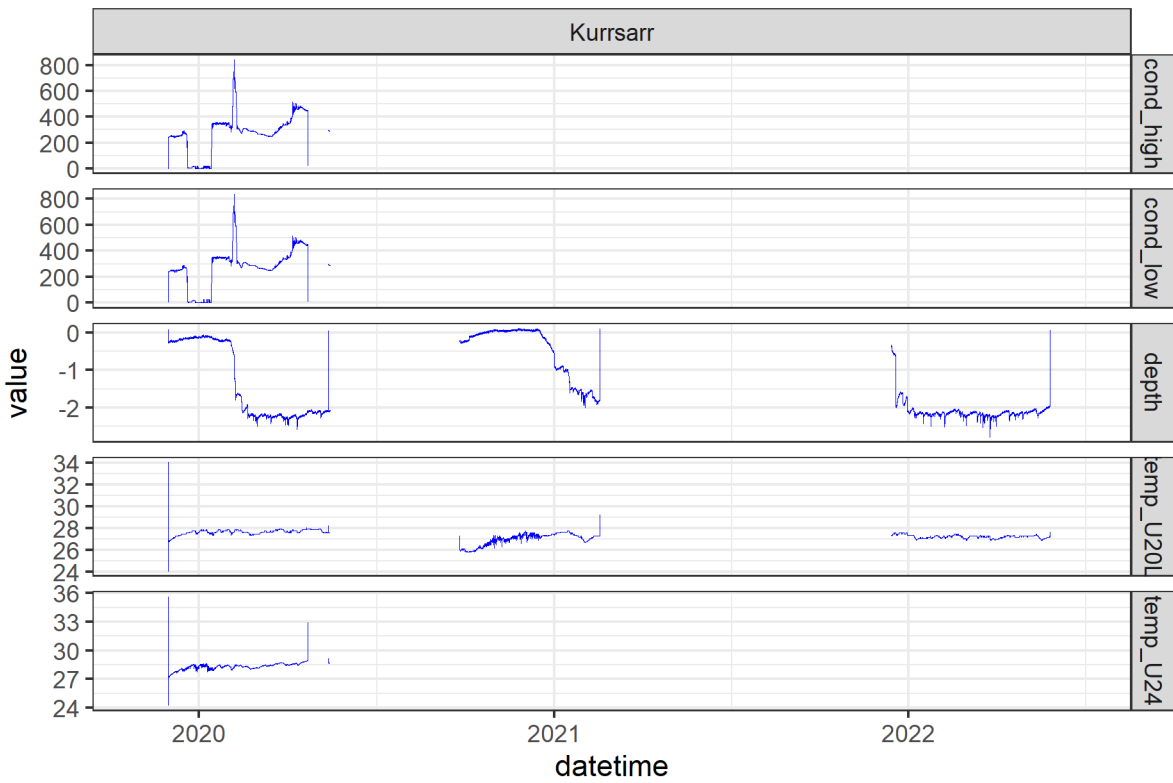
Figure A 3: Conductivity, depth, and temperature at the Kurrsarr Well at St Paul's.

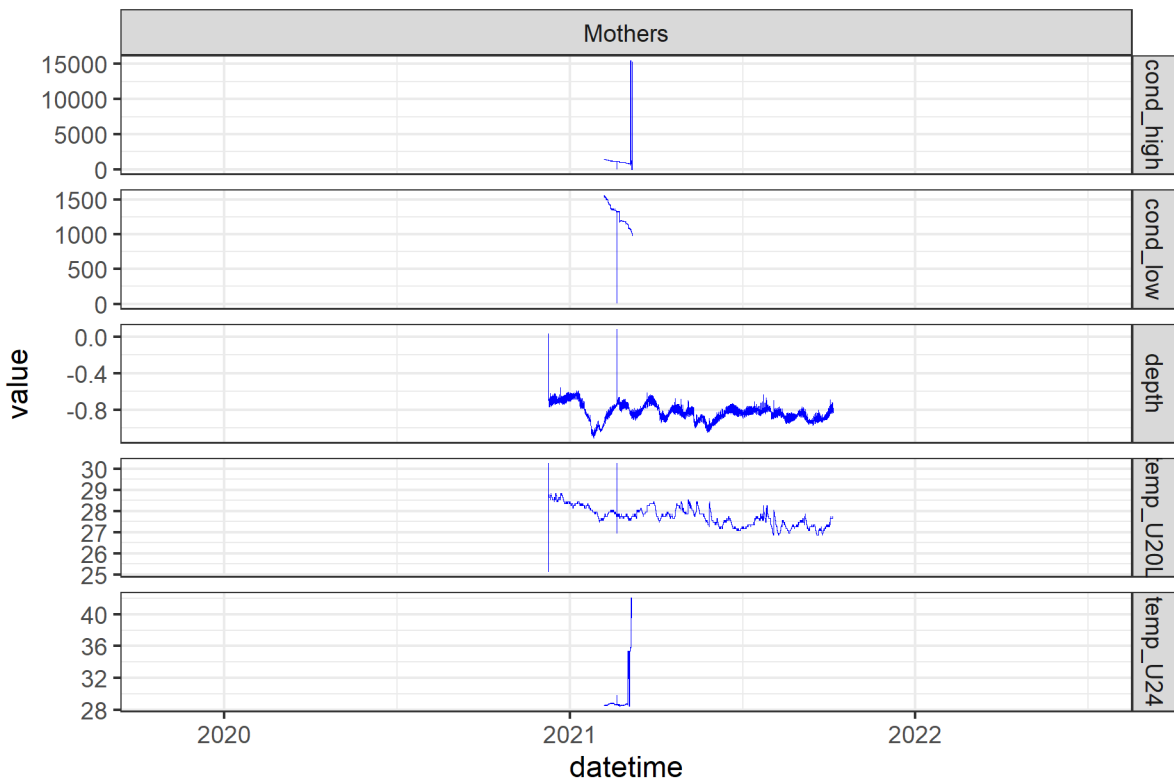
Figure A 4: Conductivity, depth, and temperature at the Mothers Well on Masig Island.

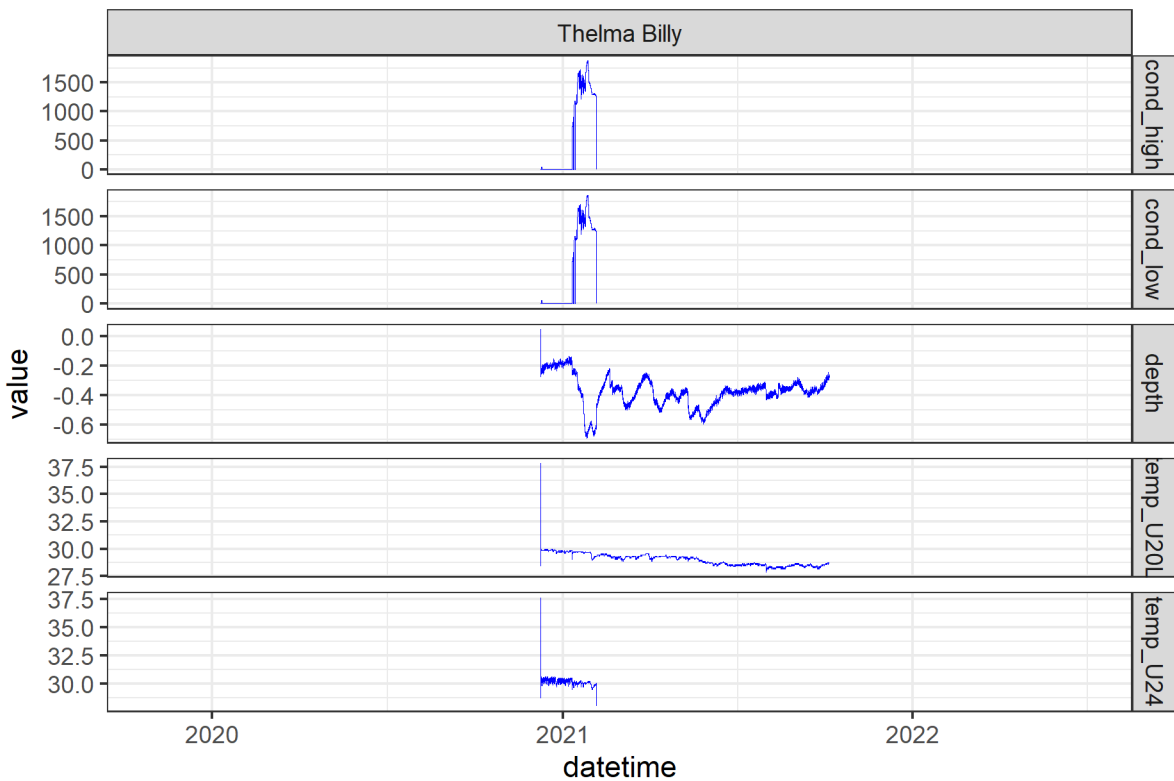
Figure A 5: Conductivity, depth, and temperature at the Thelma Billy Well on Masig Island.
