Assessment of the effects of foreshore nourishment and mitigation projects on seagrass ecosystems (SRMP-004)

GCWA Scientific Research and Management Program

December 2016

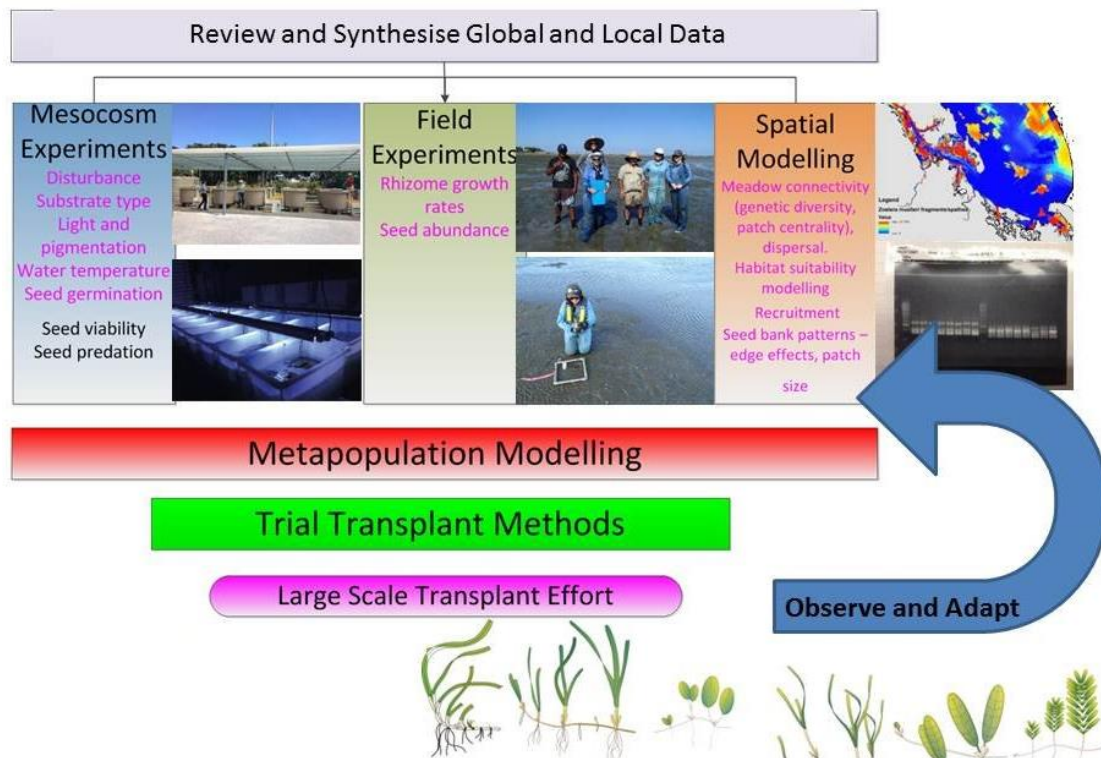
Fig. 2. Illustration of approaches that can inform the improvement of methods to restore seagrass. Experiments in tanks (mesocosms) can be used to test the influence of specific factors (e.g. light) on biological processes (e.g. seed viability and germination). Field experiments and surveys are useful to assess how seagrass performs at sites similar to restoration candidate sites. Modelling is useful to predict the likely success of sites; it draws on data from both laboratory and field experiments (source: original figure produced for this report).

Where knowledge gaps remain, attempts should be made to build the knowledge base through a combination of field observations and surveys, experiments, and modelling (Fig. 2). For example, if elevated levels of turbidity are suspected to cause seagrass failure, laboratory experiments can be useful to test the sensitivity of local species to various light and turbidity levels. Results from such experiments can then be used to model the probability of particular field sites sustaining seagrass and to validate potential restoration sites.

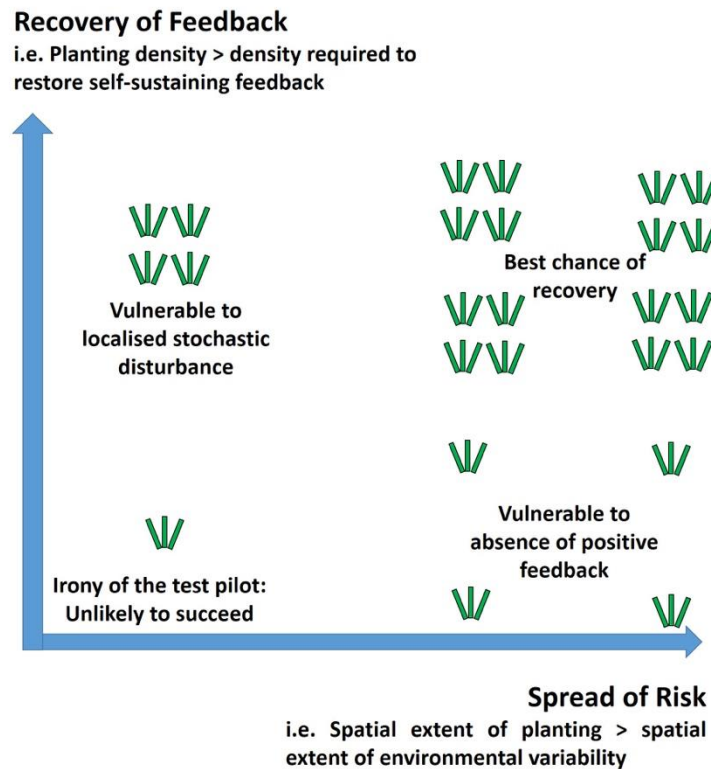
Fig. 4. Conceptual model of how planting density and the size of the meadow influence the likelihood of seagrass establishment (modified from van Katwijk et al. (2016)). Note that whilst small-scale pilot studies have a poorer success rate, they can nevertheless be important to optimise methods for the local situation and hence increase success in larger-scale projects subsequently.

Both the density of seagrass and the size of the meadow can influence the performance of restoration projects (van Katwijk et al. 2016). With increasing densities of planted individuals, and greater total areas planted, the survival percentage increases and population growth rates increase. This is believed to be driven by a 'spreading of risk' to overcome spatial variability, in combination with positive feedback mechanisms (Fig. 4).

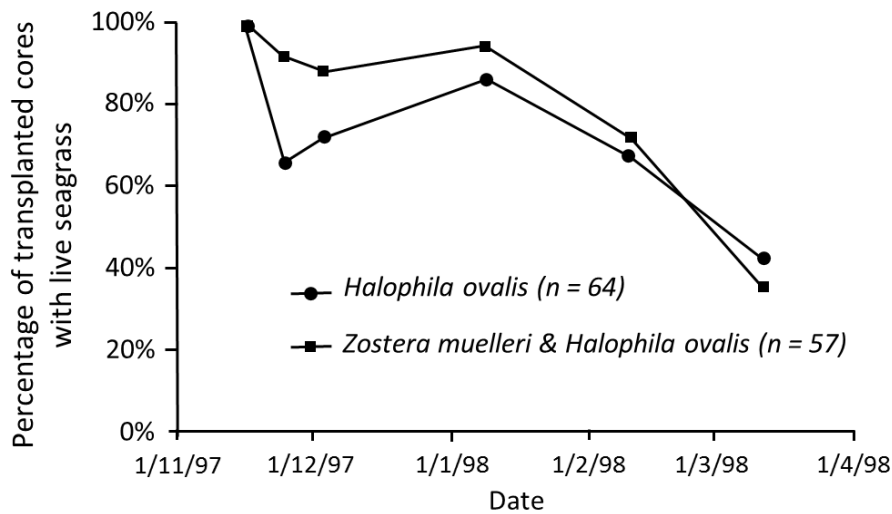
Fig. 5. Changes in the percentage of transplanted cores alive after experimental transplanting at Wavebreak Island (redrawn from McLennan & Sumpton (2005)).

Divers measured survival of cores monthly for four months after transplanting, and at eight months made a final assessment of seagrass cover (not of individual cores). Survivorship of cores was initially high, but after four months was < 50%, both for mixed species and pure *H. ovalis* cores (Fig. 5). At the final survey (8 months post-transplant), total seagrass cover in the transplanted area was 51%. Most of this seagrass, however, was considered to come from natural colonisation.

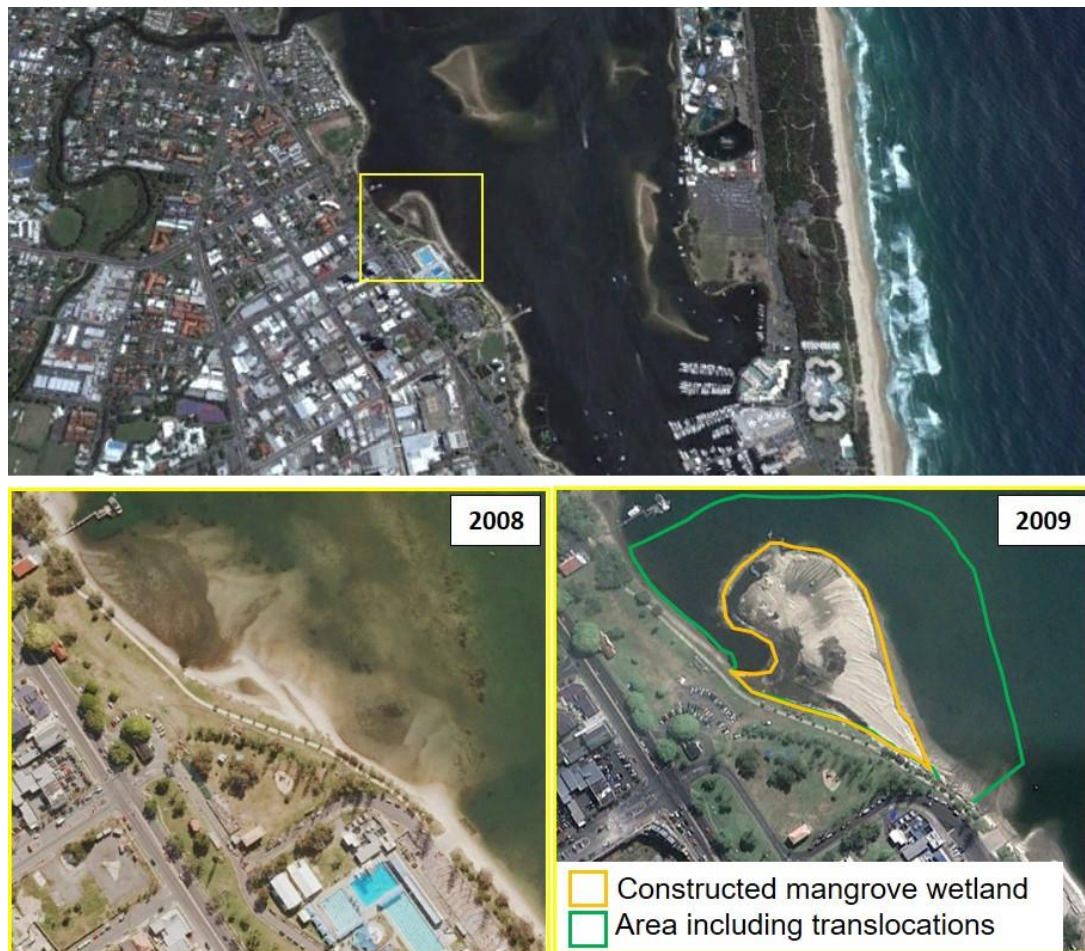
Fig. 6. Constructed mangrove wetland and translocation area, Southport Broadwater Parklands Stage 1. Lower left and lower right images illustrate the general seagrass translocation area (VDM Consulting 2010) before (26 July 2008) and after construction of the mangrove wetland (30 April 2009) (Google Earth 2016).

reclamation (VDM Consulting 2010). Prior to the transplant works (2009), the transplant area (Fig. 6) was described as being influenced by a number of anthropogenic factors including high turbidity, sedimentation, bioturbation, nutrient loading from runoff, dredging, and boat traffic (VDM Consulting 2010). There was a suggestion that the construction of the mangrove wetland would improve the quality of stormwater inputs at the site, improving nearby conditions for seagrass growth.

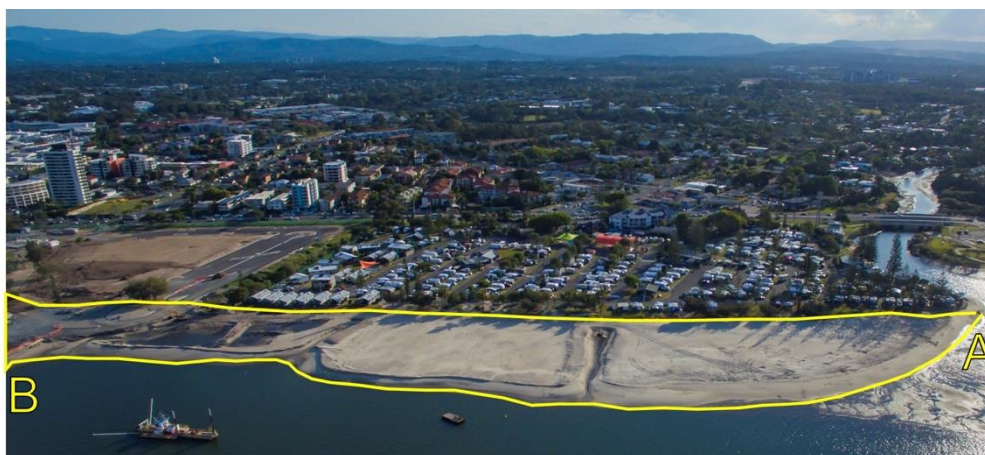
Fig. 8. Aerial photograph illustrating progress of the foreshore development area in September 2015 (outlined by yellow boundary) as part of the Southport Broadwater Parklands Stage 3 (photo: R Connolly).

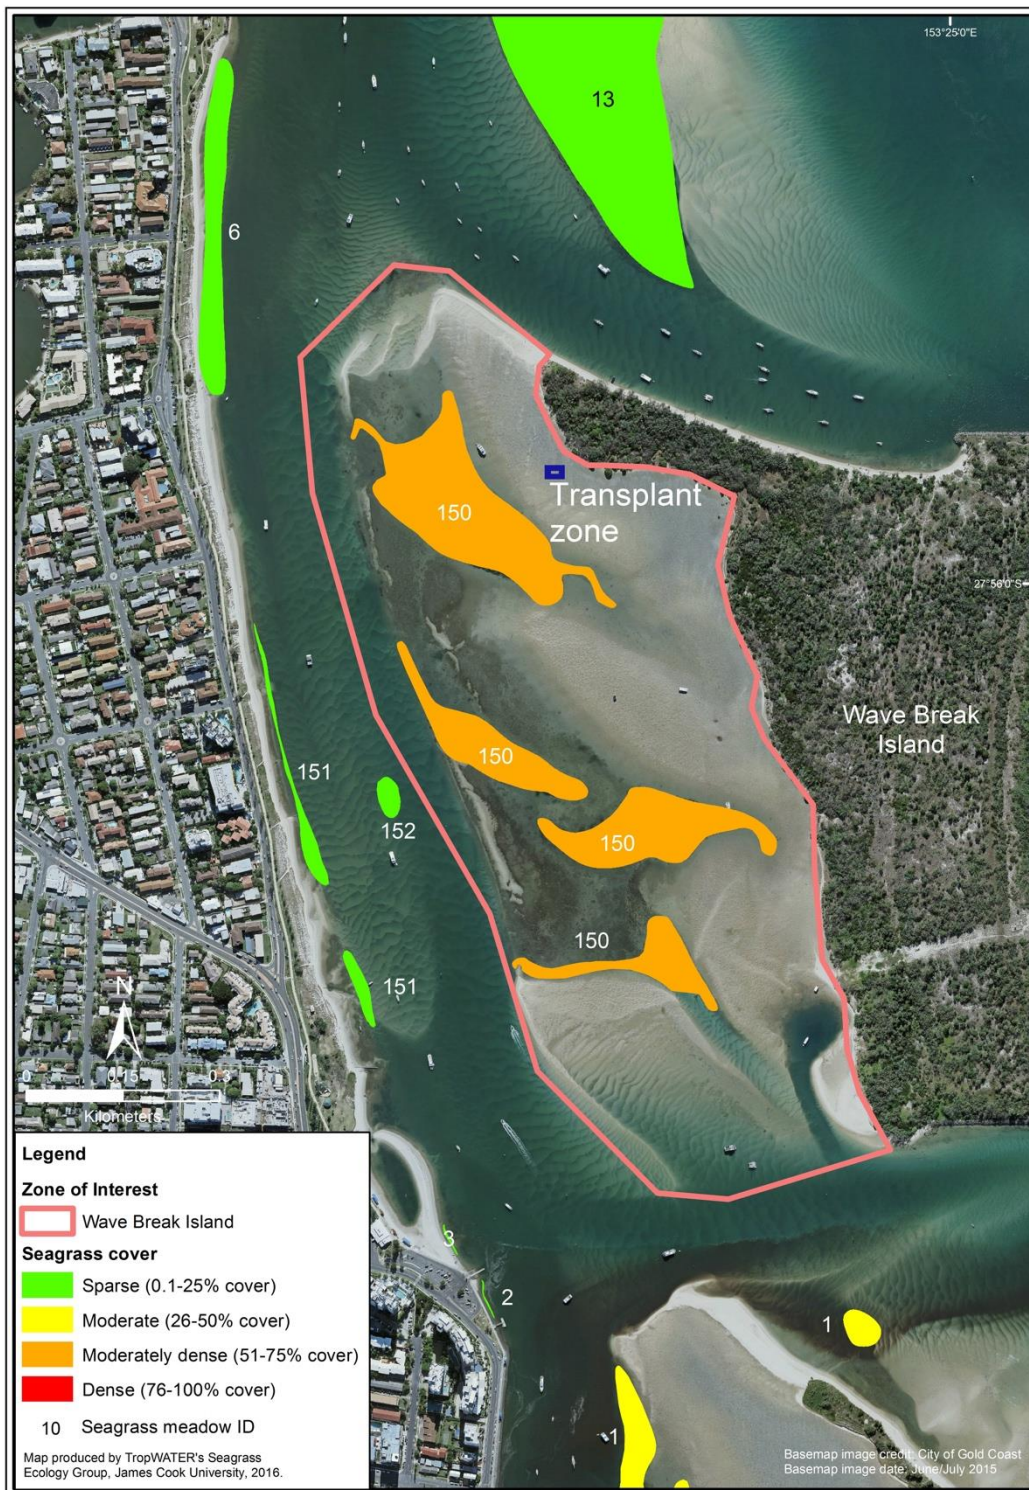
Fig. 9. Seagrass meadows located in and adjacent to Wave Break Island (seagrass transplant associated zone). Patches of dark colouration not reported as surveyed seagrass can be areas of, among other things, rock substrate, mud or discoloured sand, or macroalgae either attached or drift.

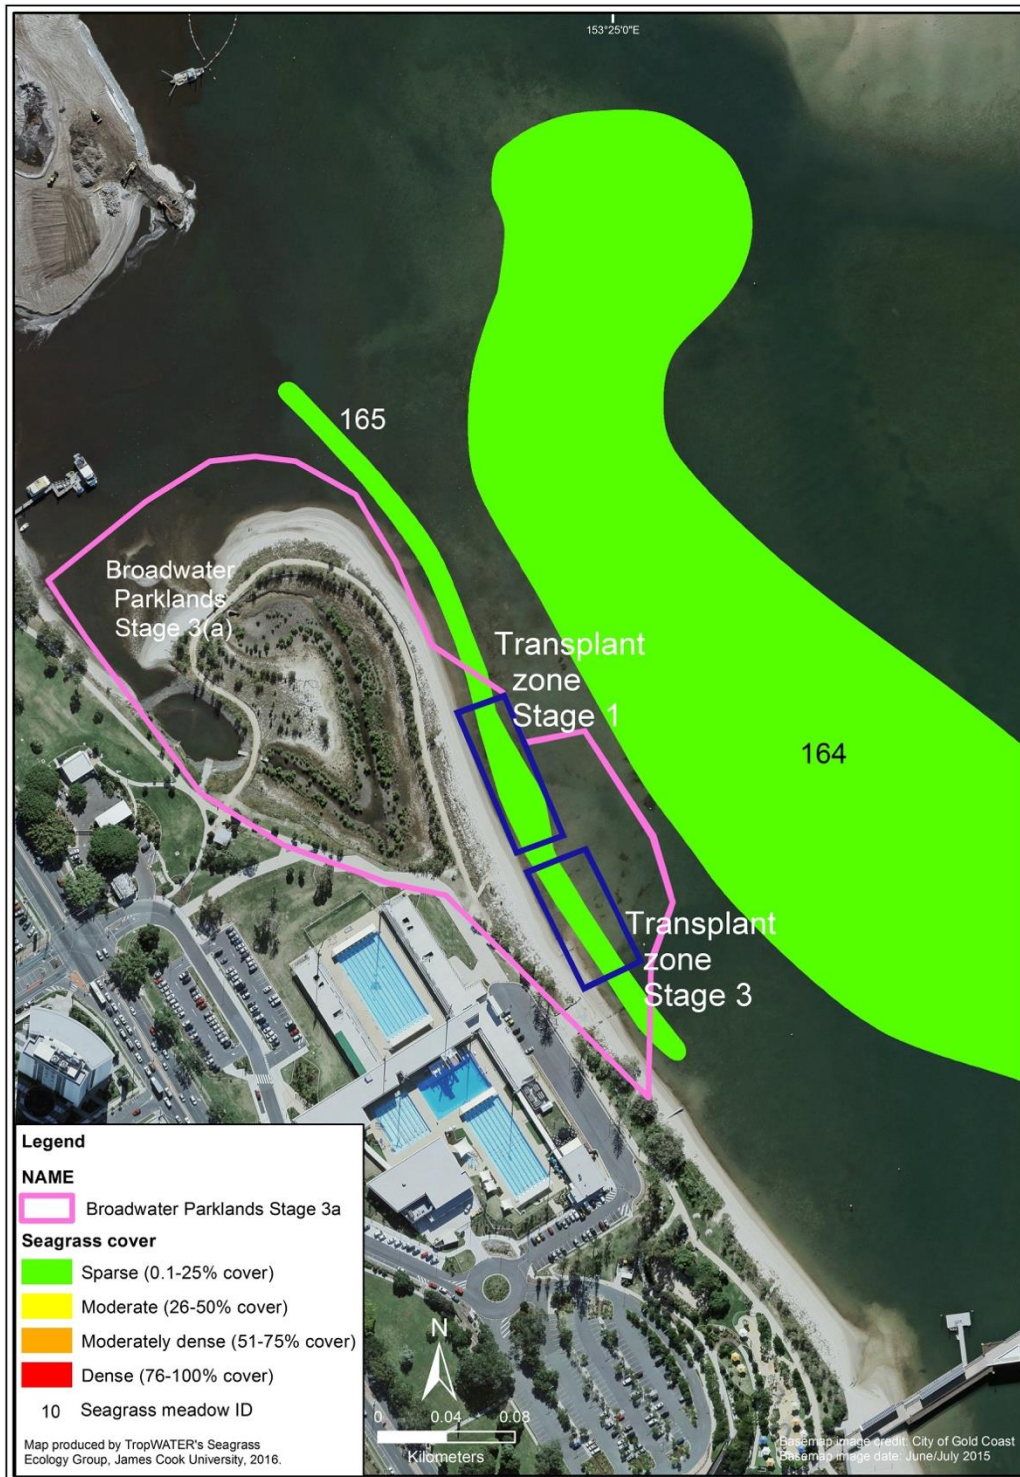
Fig. 11. Seagrass meadows located in and adjacent to Broadwater Parklands Stage 3a (seagrass transplant, sand nourishment, mangrove habitat creation zone). Patches of dark colouration not reported as surveyed seagrass can be areas of, among other things, rock substrate, mud or discoloured sand, or macroalgae either attached or drift.

This area contained a thin strip of sparse seagrass patches (Meadow 165, Fig. 11) adjacent to the constructed mangrove wetlands. These patches were found in the intertidal and shallow subtidal zones (Table 4; Fig. 11). The meadow was dominated by *Z. muelleri* with some *H. ovalis*, which matches species observed during previous surveys in the same area (Sillars 2011, Ebrahim 2012, Henkelmann 2012, Element Ecology 2014b). However a third species, *H. spinulosa*, previously recorded in the

area and which was also transplanted during Stage 3, was not reported at all from this meadow. An additional meadow (164) of sparse seagrass was recorded in deeper water, adjacent to the reporting zone. A meadow in this area has previously been reported (see VDM Consulting (2012), Cuttriss et al. (2013), Element Ecology (2014a)).

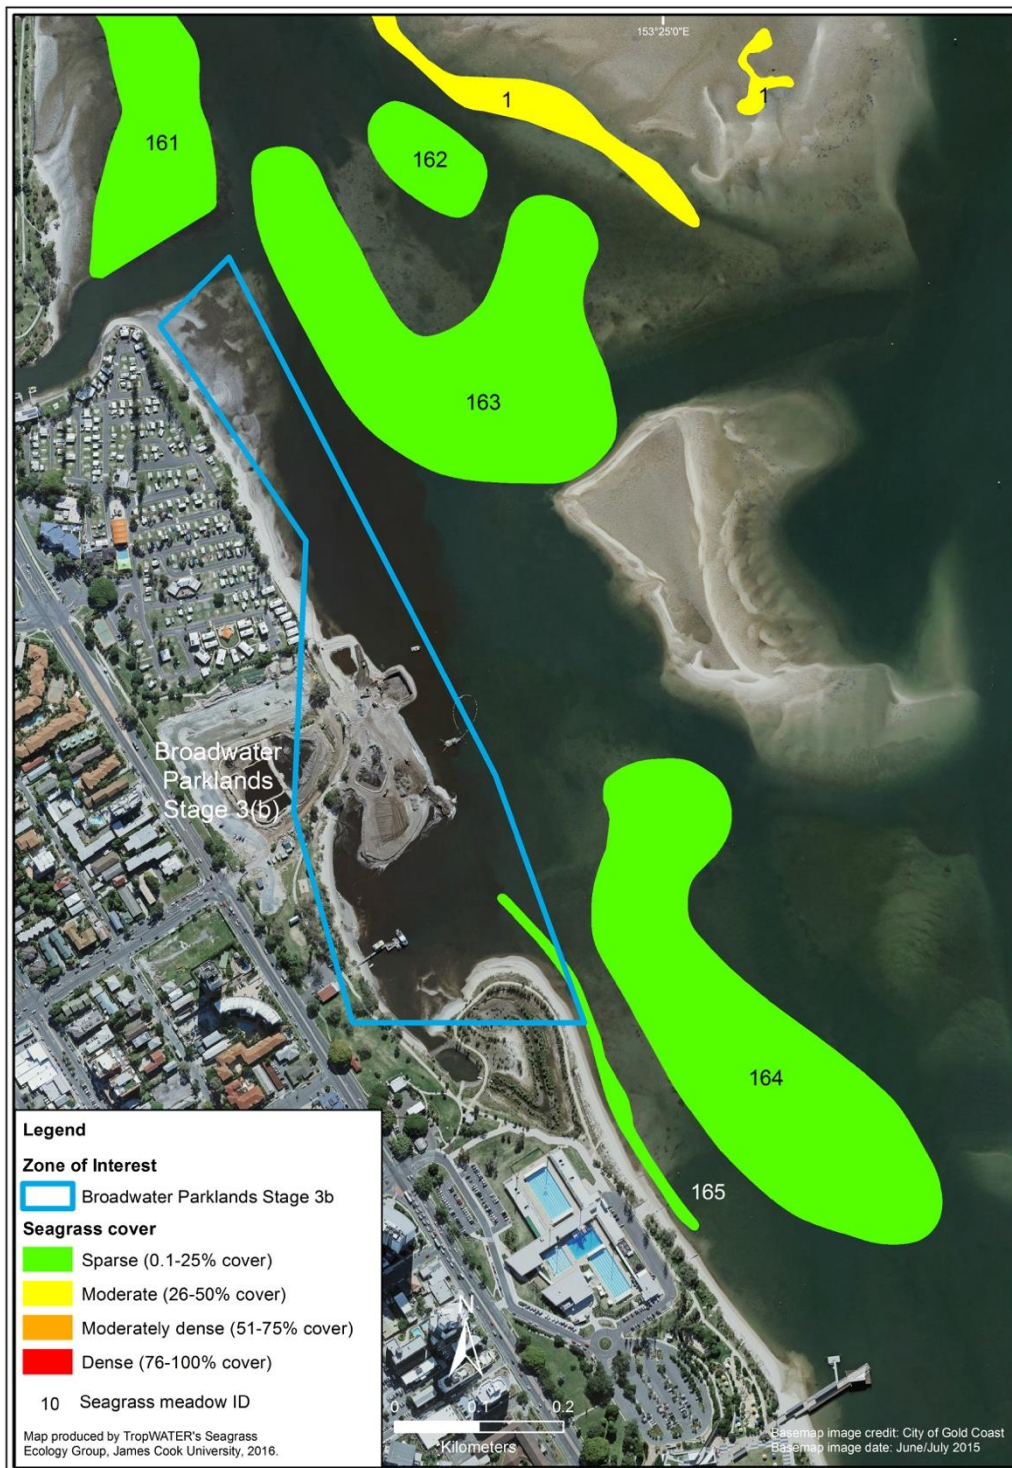
Fig. 12. Seagrass meadows located in and adjacent to Broadwater Parklands Stage 3b (sand nourishment, foreshore development zone). Patches of dark colouration not reported as surveyed seagrass can be areas of, among other things, rock substrate, mud or discoloured sand, or macroalgae either attached or drift.

No seagrass was recorded along the newly aligned foreshore in the central and northern parts of the reporting zone (Fig. 12). This is an area where the foreshore continued to be actively filled with dredge material up until the time of the survey. Seagrass was observed at the southern end of the reporting zone in the form of an extension of Meadow 165 (described above in Broadwater Parklands Stage 3a) (Table 4; Fig. 12), but this is not where the Stage 3 foreshore realignment occurred.

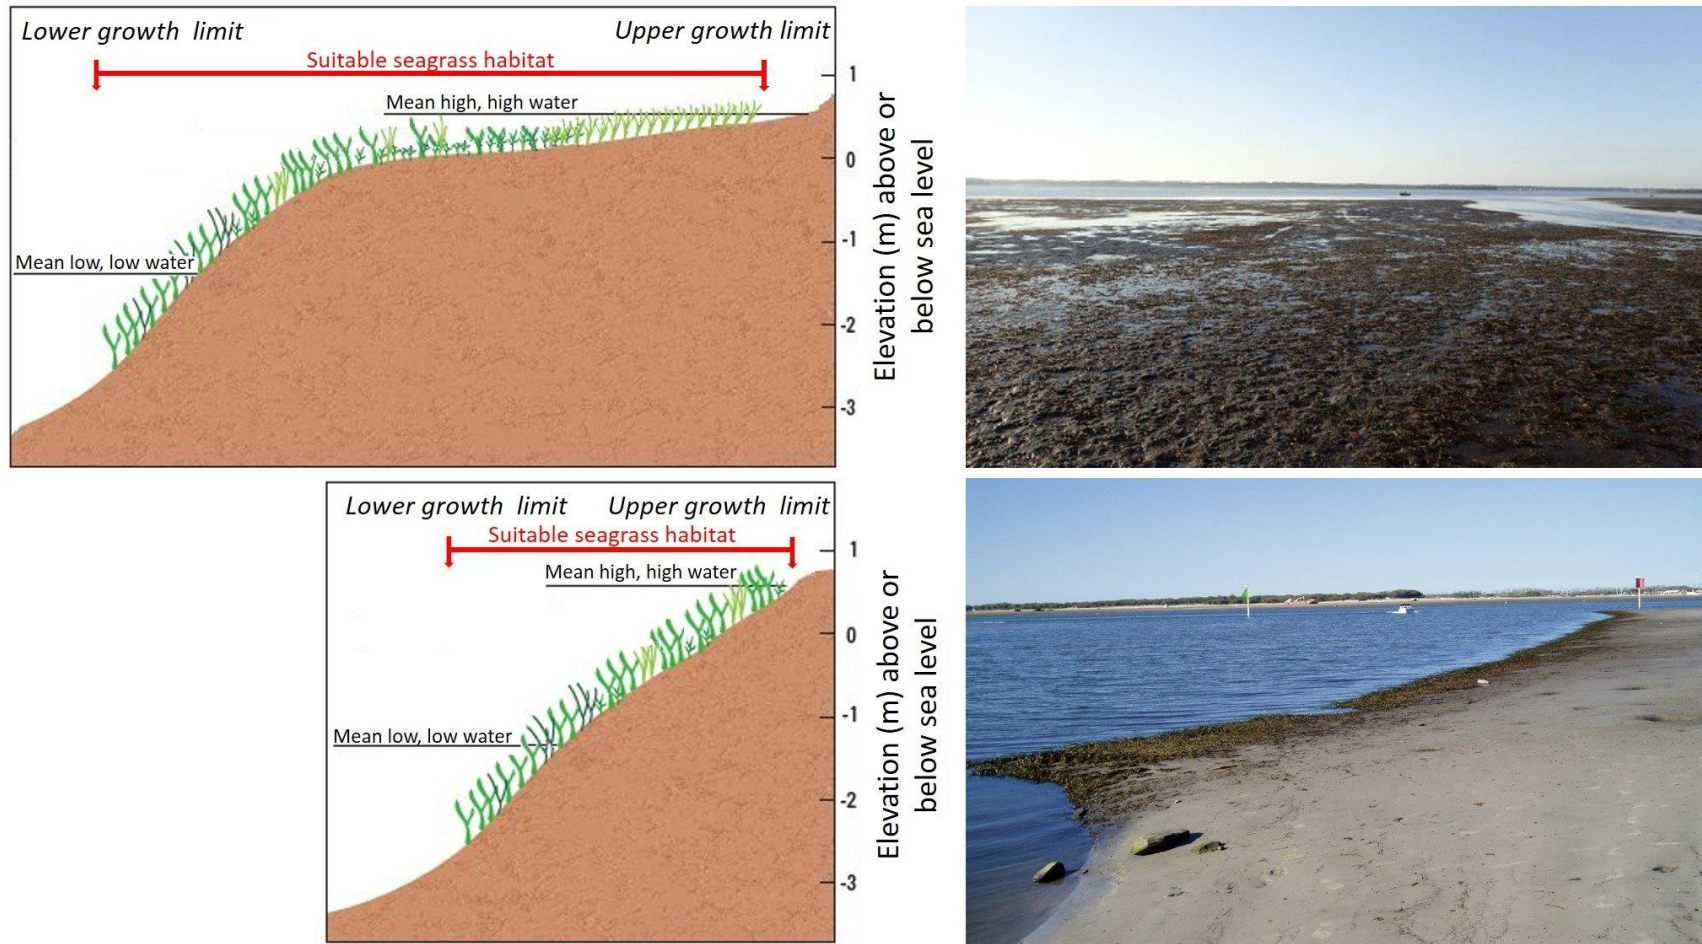
Fig. 15. The relationship between sand slope and total seagrass area with reference to the upper and lower growth limits. Upper images represent an area with a gentle slope that results in a large area of seagrass. The lower images represent areas with steep slopes, and a corresponding smaller total seagrass area. Photographs on right show Gold Coast examples of each situation. Upper: northern side of Loders Creek, central Broadwater (photo: S McKenna) and lower: southern side of Loders Creek (photo: R Connolly).

The upper limit of seagrass habitat is primarily regulated by seagrass tolerance to desiccation at low tide (Koch & Beer 1996). The lower limit, however, is regulated by available incident radiation and light attenuation in the water column (Kilminster et al. 2015). The horizontal distance between these upper and lower growth limits governs the amount of suitable substrate. For example, where the upper and lower growth limits are separated by large horizontal distances (e.g. in a gently sloping intertidal zone), large areas are available for seagrass habitat. On the other hand, small distances between vertical limits (e.g. in a sharply sloping foreshore) compress the available area suitable for seagrass growth (Fig. 15). As such, foreshore slope is influential in dictating the area of suitable habitat but not the presence of seagrass. This is because all foreshore slopes on soft-sediment substrates have the potential to provide opportunity for seagrass growth, irrespective of the degree of slope¹, were water, sediment and hydrodynamic conditions are favourable (Silberstein et al. 1986, Fourqurean et al. 1992, Koch 2001).
