# **Half Tide Tug Harbour, Hay Point Marine Plant Assessment September 2021**

**Paul York & Skye McKenna**  
Report No. 21/54

North Queensland Bulk Ports (NQBPs) engaged TropWATER at James Cook University to undertake a survey of the presence of marine plants (seagrass and algae) within the Half Tide Tug Harbour at the Port of Hay Point, and a survey area of 31.6 Ha. The survey required assessment of marine plant distribution in the area proposed for expanded maintenance dredging, as well as a contemporary survey of marine plants in the area currently approved for dredging (14.8 Ha - Figure 1).

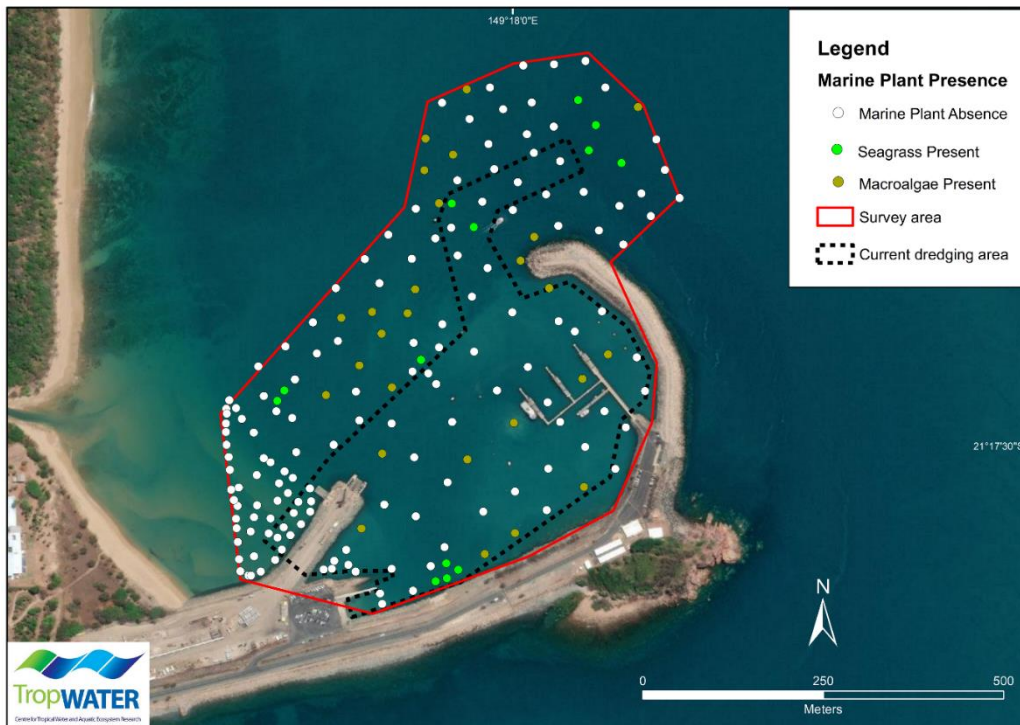
**Figure 1.** Presence of marine plants at Half Tide Tug Harbour in September 2021. (Image credit: ESRI).

A total of 184 sites were surveyed across the entire area, with seagrass observed at 13 of those sites and estimated to occupy approximately 1.25 ha at very low biomass of 0.1 g DW m<sup>2</sup>. Overall, two species of seagrass were observed with *Halophila decipiens* dominant and occurring at 12 sites and *Halophila ovalis* observed at one site. Macroalgae was also observed at 27 sites out of the 184 sampled and estimated to cover an area of approximately 4.4 Ha of sparse habitat (Figure 1).

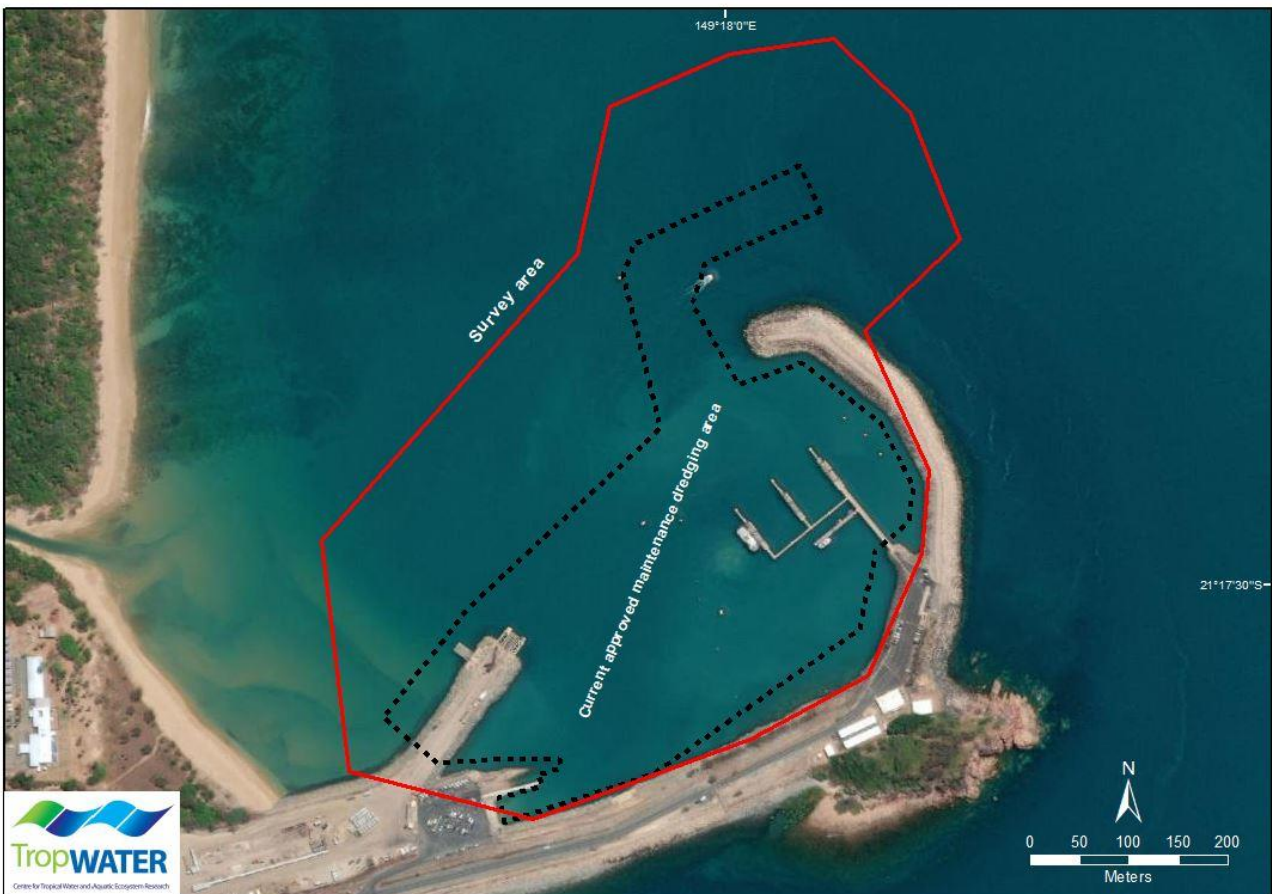
**Figure 2.** Marine plant survey area (inside the red line) showing survey boundaries for the current approved maintenance dredging area (inside black dotted line) and the newly proposed area of maintenance dredging requiring an higher intensity of sites (outside the black dotted line).

North Queensland Bulk Ports (NQBP) have engaged the Centre for Tropical Water and Aquatic Ecosystem Research at James Cook University (TropWATER) to undertake a survey to determine the presence/absence of marine plants within the Half Tide Tug Harbour, located at the Port of Hay Point (Figure 2). The TropWATER team is currently responsible for the annual seagrass long-term monitoring program in the Hay Point/Mackay area, and has previously conducted extensive benthic habitat assessments in the Hay Point area (2004, 2014, 2010, 2016-2021) as well as the benthic surveys for the HPCT Berth 2 Ship Loader Upgrades in 2019 and 2020.

Specifically, the survey requires assessment of marine plant distribution in the area proposed for expanded maintenance dredging, as well as a contemporary survey of marine plants in the area currently approved for dredging (Figure 2).

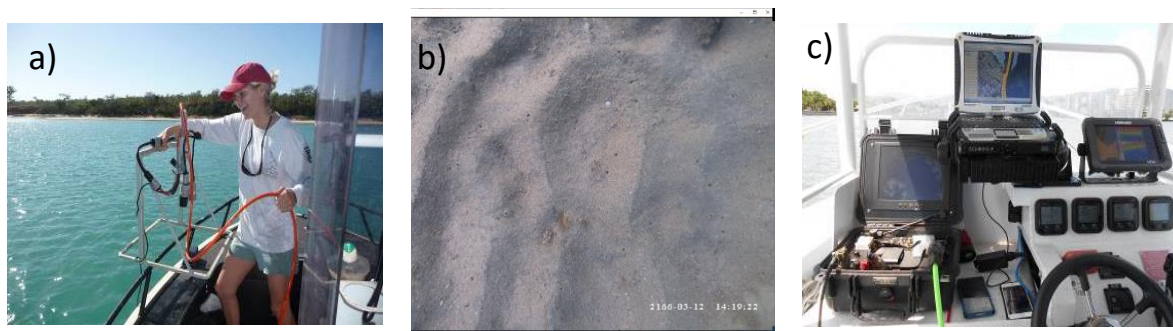
**Figure 3.** Monitoring set ups for marine plant habitat assessments using live digital cameras (a & b) and on-vessel assessment, spatial referencing and recording of images (c).

- The Half Tide Tug Harbour area was monitored from a small vessel using a digital camera mounted on a drop frame that provided a live feed to a monitor on the surface. The transmitted image incorporated a 0.25m<sup>2</sup> view of a quadrat on the seafloor from which a researcher could estimate habitat cover, biomass and species or functional groups present (Figure 3). At each site key seagrass, macroalgae and sediment information from three random placements of the quadrat were collected.

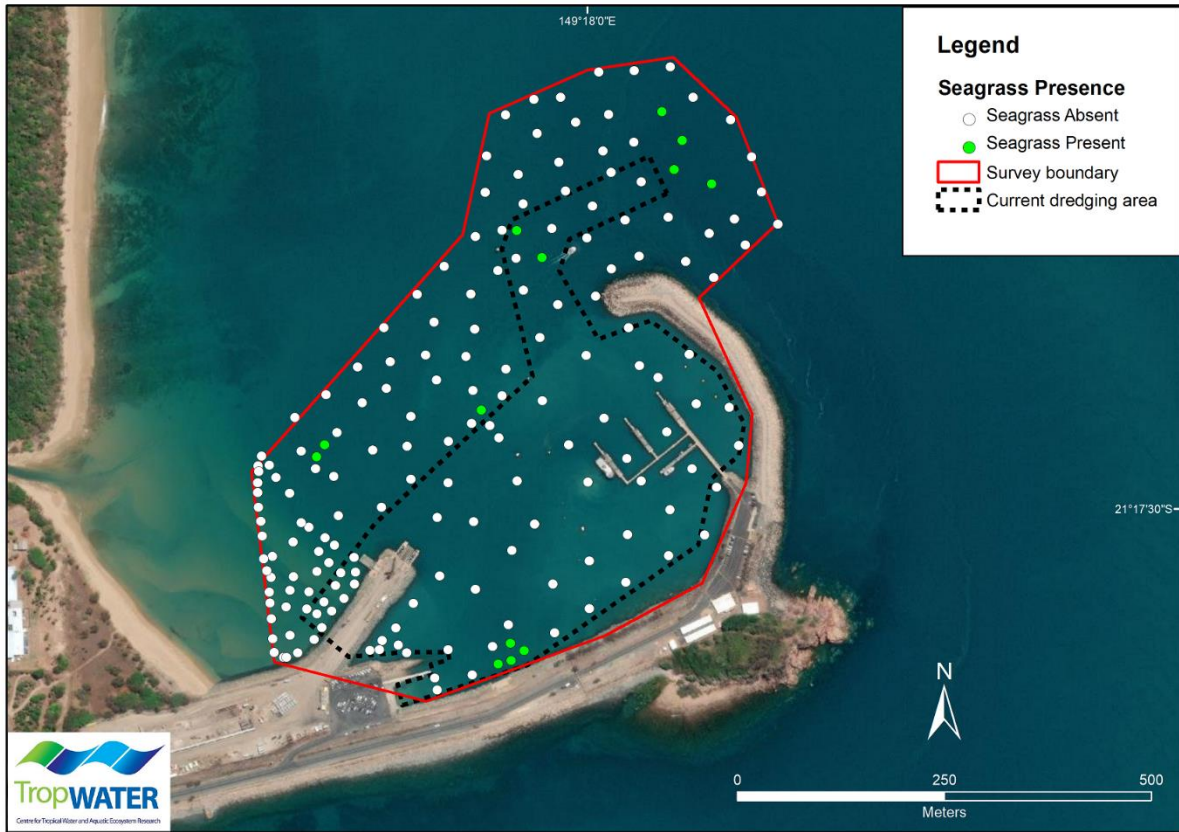
Figure 4. Presence of seagrass at Half Tide Tug Harbour in September 2021. (Image credit: ESRI).

The benthic habitat in the area currently approved for maintenance dredging consisted of open substrate of sandy and muddy sediments with both seagrass and macroalgae present at some of the assessment sites (Figures 4, 5 & 8). Seagrass from colonising species *H. decipiens* and *H. ovalis* occurred at six sites and covered an estimated area of 0.4 ha in a sparse and patchy distribution. The mean biomass throughout this area was  $0.09 \pm 0.02$  g DW m<sup>2</sup> (Figure 6). Macroalgae in this area was present at 9 sites and covered an area of approximately 1.9 Ha with sparse ground cover averaging around 6.6% (Figure 7).

The benthic habitat for the extended area proposed for maintenance dredging also consisted of open substrate of sandy and muddy sediments with both seagrass and macroalgae present (Figures 4 & 5). In this area one seagrass species, *H. decipiens*, was observed at 7 sites covering an area estimated at 0.9 Ha (Figure 6). Seagrass was sparse and patchy with a mean biomass of  $0.11 \pm 0.03$  g DW m<sup>2</sup>. Macroalgae in this area was present at 18 sites and covered an area of approximately 2.5 Ha with sparse ground cover averaging around 5.3% (Figure 7).

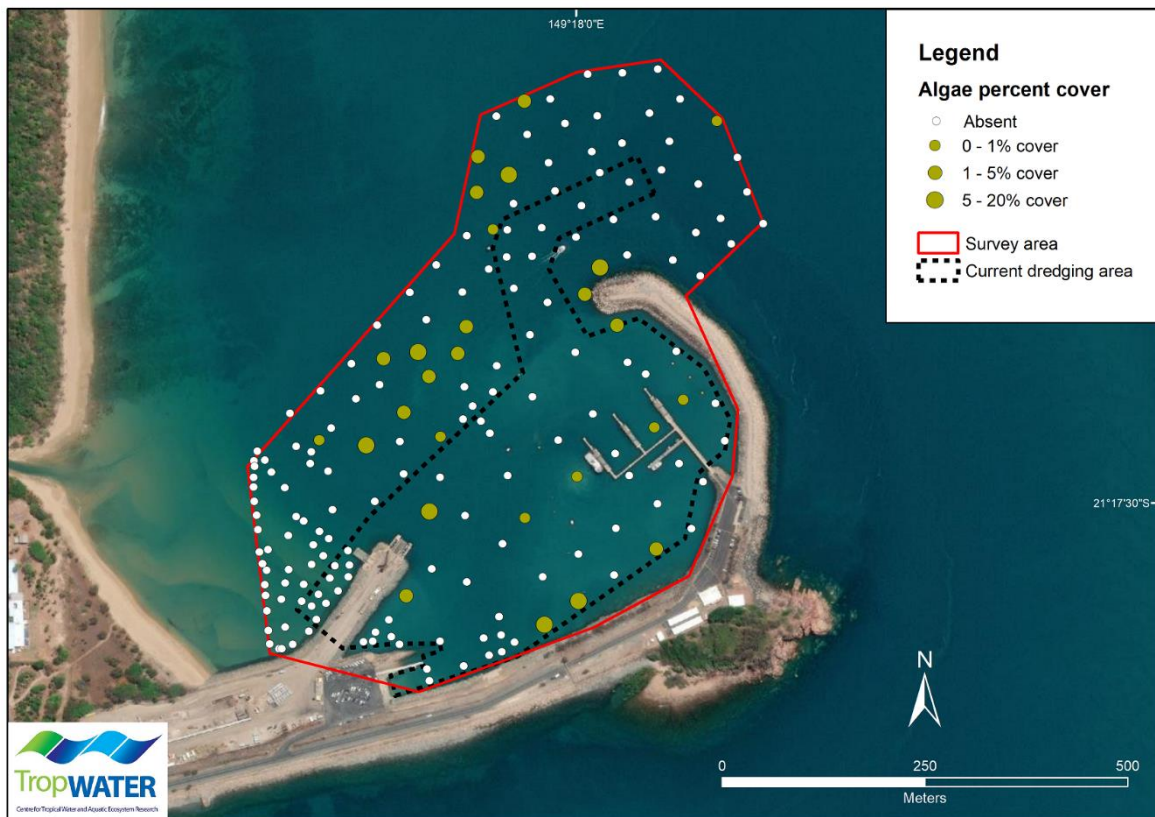
Figure 5. Presence of macroalgae at Half Tide Tug Harbour in September 2021. (Image credit: ESRI).

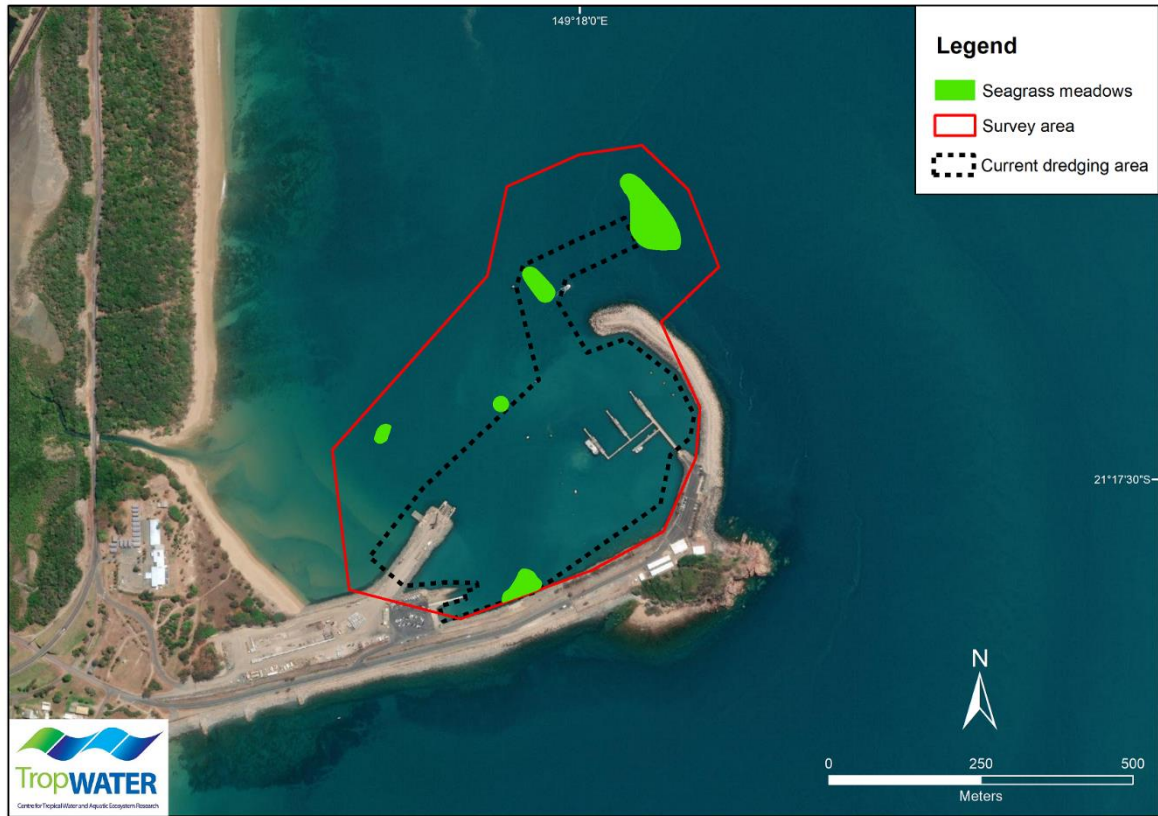
Figure 6. Distribution of seagrass at Half Tide Tug Harbour in September 2021. (Image credit: ESRI).

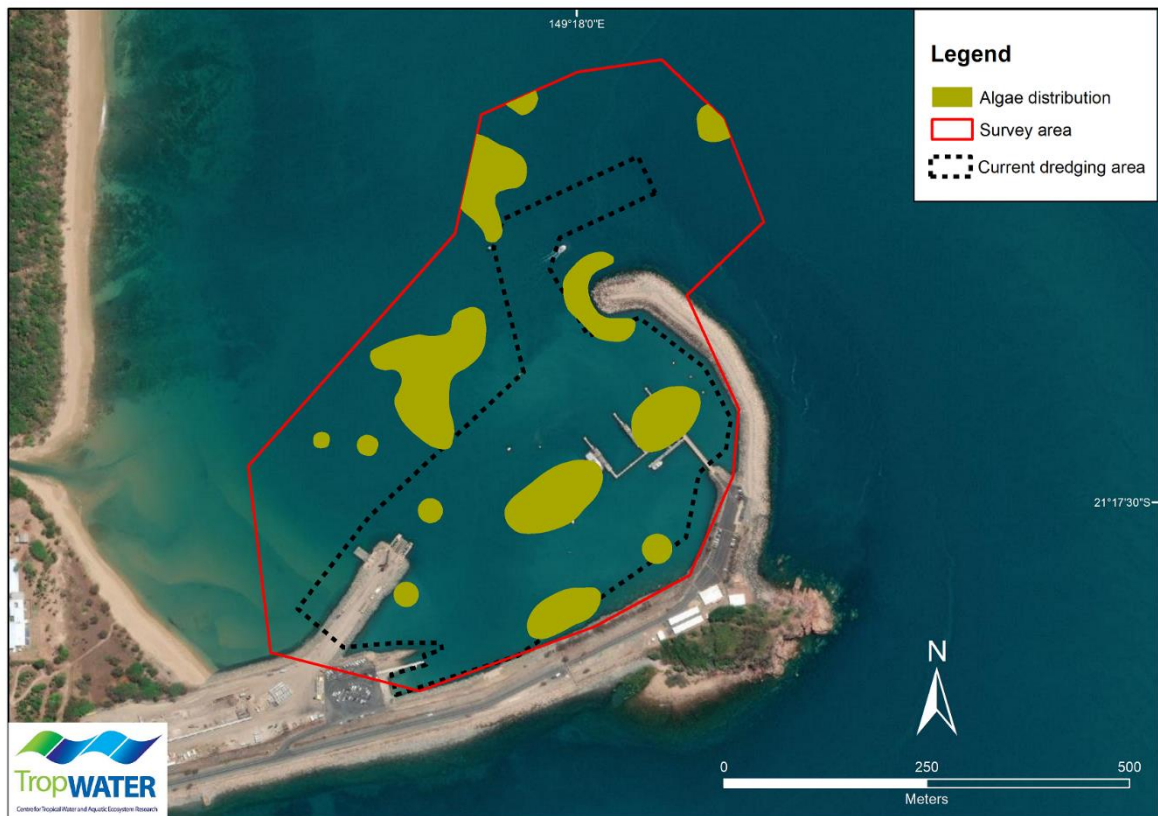
Figure 7. Distribution of macroalgae at Half Tide Tug Harbour in September 2021. (Image credit: ESRI).

Marine plant surveys in the survey area at the Half Tide Tug Harbour were conducted between 23<sup>rd</sup>-25<sup>th</sup> September 2021. Favourable weather and sea state conditions provided good in-water visibility for the assessment of benthic habitats using a live-feed, remote camera. One hundred and eighty four (184) sites were assessed during the survey of the current and proposed maintenance dredge area with three separate camera drops at each site (Figures 4 and 5). Seagrass was observed at 7% of sites sampled (13 sites – Figure 4) and macroalgae was observed at 15% of sites sampled (27 sites – Figure 5). Overall, two species of seagrass were observed in the Half Tide Tug Harbour, with *Halophila decipiens* dominant and occurring at 12 sites and *Halophila ovalis* observed at one site. Seagrass habitat was estimated to cover an area of 1.25 Ha at very low biomass of 0.1 g DW m<sup>2</sup> (Figure 6). A further 4.4 ha of the Half tide Tug Harbour was estimated to be covered with sparse (approx 6 % cover) macroalgal habitat (Figure 7).

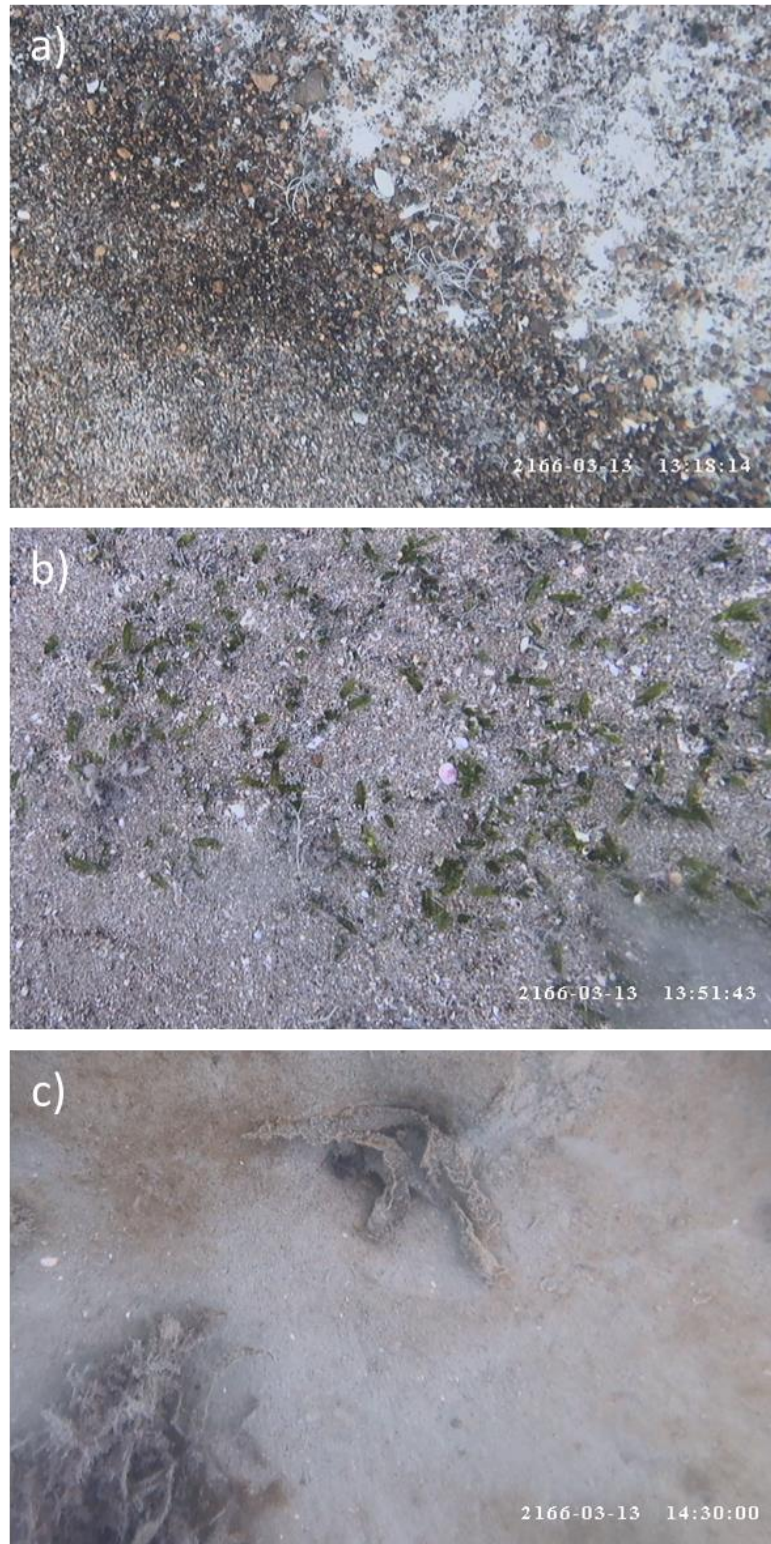
**Figure 8:** Screenshots of different marine benthic habitat seen during the survey including; a) open sandy substrate b) sandy substrate with patches of seagrass and c) muddy substrate with macroalgae
