Cairns Regional Council: Half Moon Bay Offshore Disposal Area - Marine Plant Survey and Ecological Assessment - December 2022

December 2022 | Report No. 22/57

Centre for Tropical Water & Aquatic Ecosystem Research (TropWATER) James Cook University

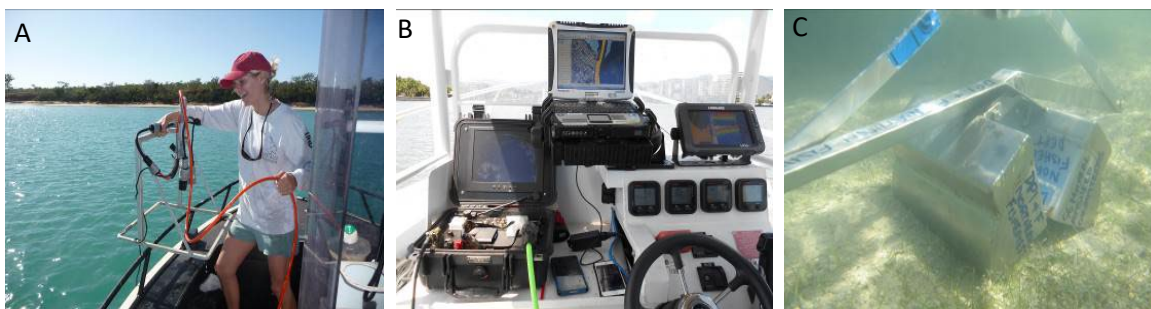
Figure 2. Benthic habitat assessments using (a & b) live digital camera and (c) Van Veen sediment grab.

- Digital camera mounted to a drop frame provided a live feed to the surface and incorporated a 0.25m² view of the seafloor from which a researcher could estimate habitat cover, density and functional groups present (Figure 2a & b);
- Van Veen sediment grab (grab area 0.0625 m²) captured a sample of the upper seafloor sediment to confirm species/habitat type seen on the screen (Figure 2c).

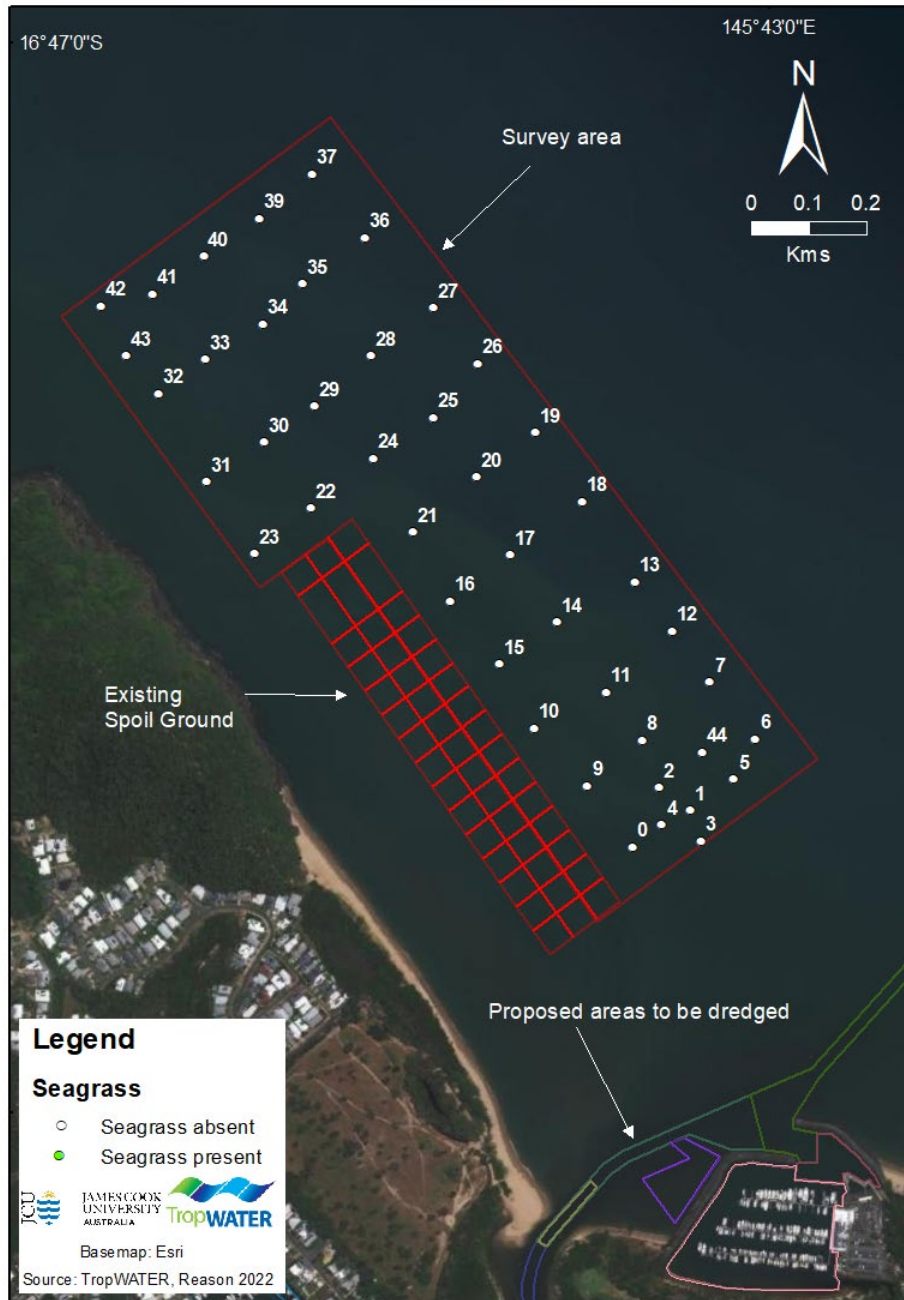
Figure 3. Habitat assessment sites displaying marine plant presence/absence. No other benthic habitats were present at assessment sites.

Marine plant assessments in the area of interest (Figure 1 & 3) were conducted on the 1st of December 2022. Forty-four sites were assessed for marine plants in the survey area.

No seagrass was found at any assessment sites within the survey area (Figure 3). No algae or any other benthic habitat forming species were present at any assessment sites. Across all the sites the sediment was predominately mud or sand or a combination of the two (Figure 4). Some sites dominated by sand had ripples indicating sediment movement and a recent shifting from wave action occurring at the site.
